Alcatraz Island Geotechnical Evaluation and Shoreline Erosion Study

William V. McCormick, CEG
Santa Rosa, CA

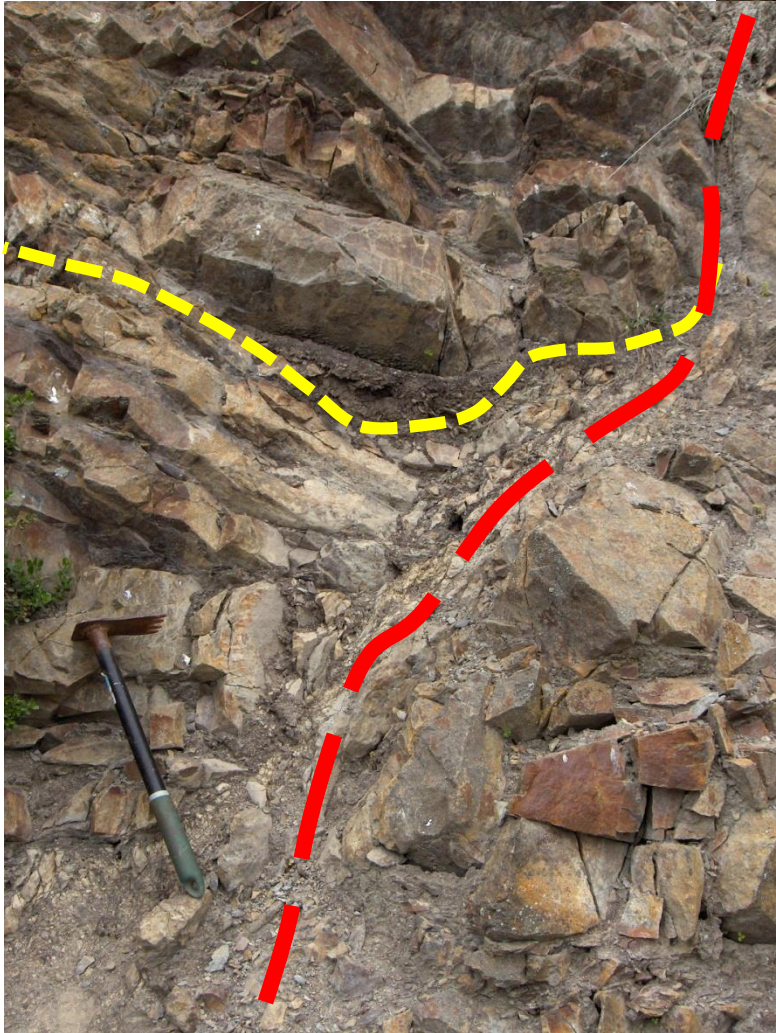
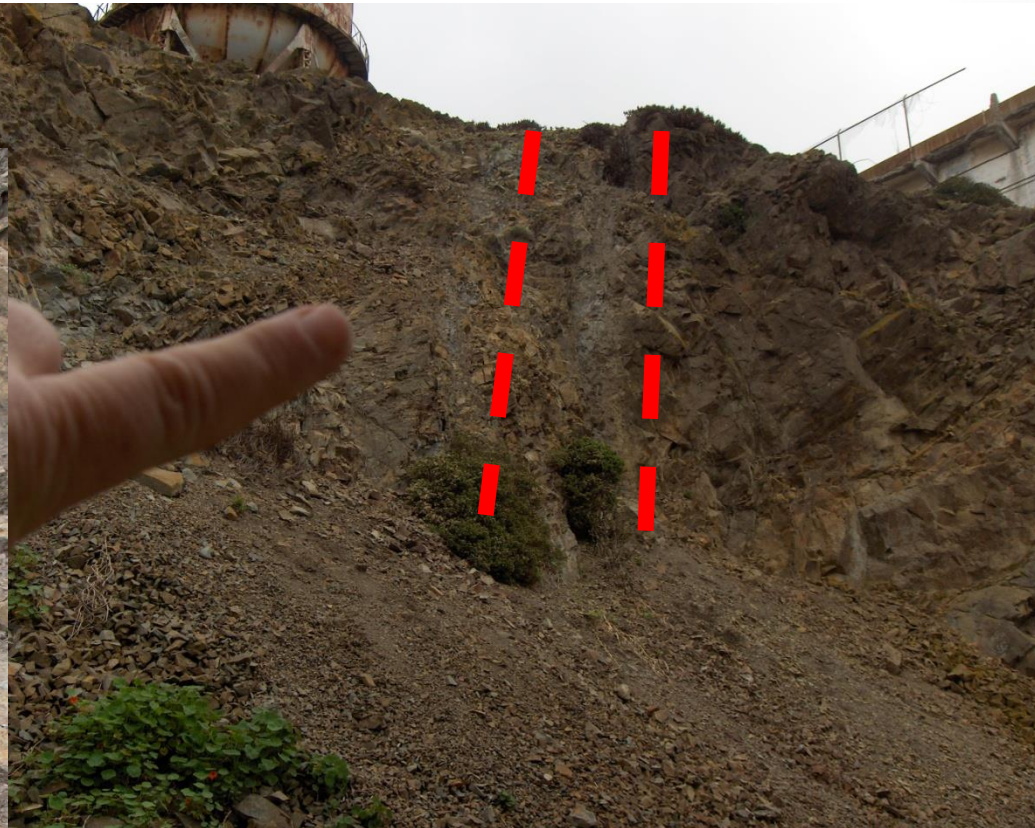
Main Fault Shears with Horizontal Striations
in Old Quarry Slopes

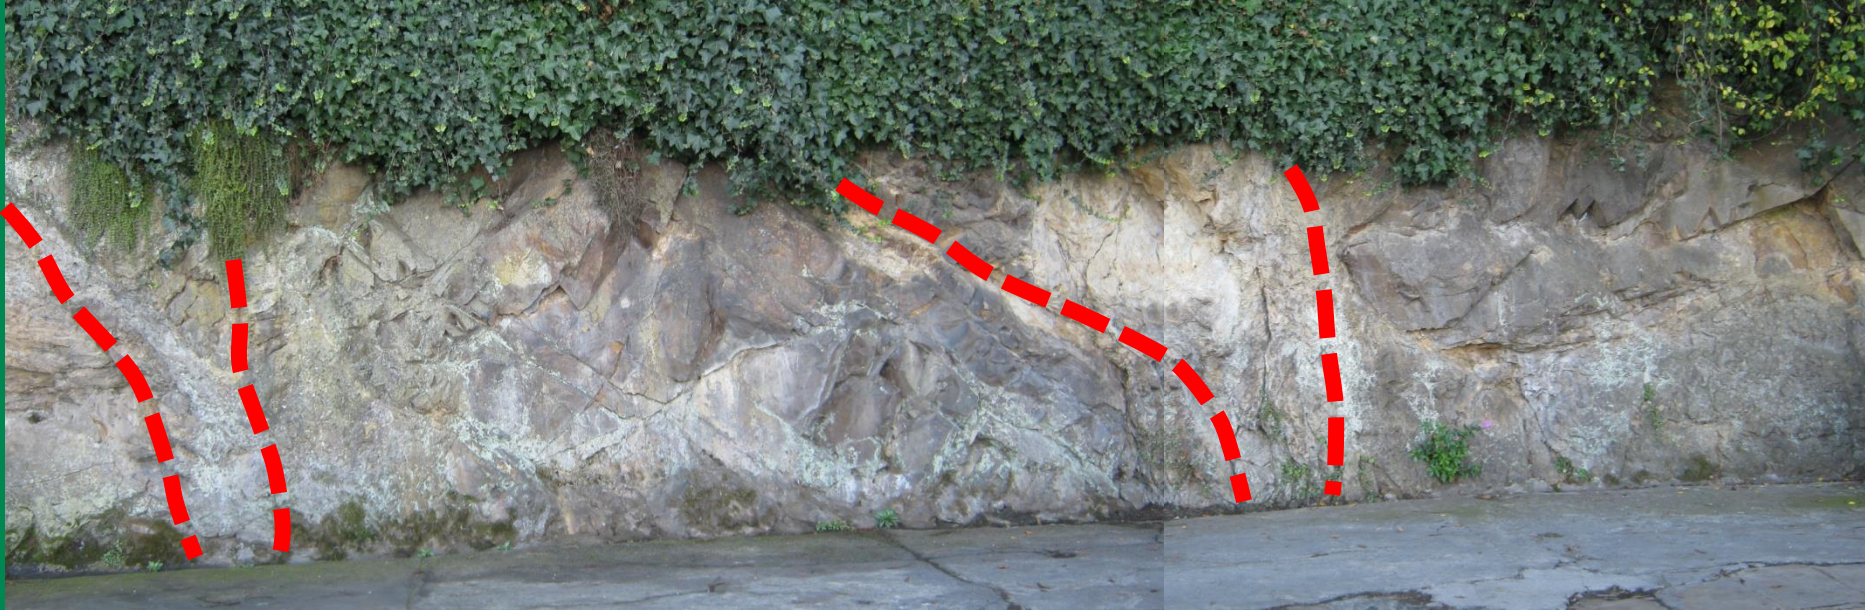
Fault Shear Zone with Distorted and Truncated Bedding, East Side of Island

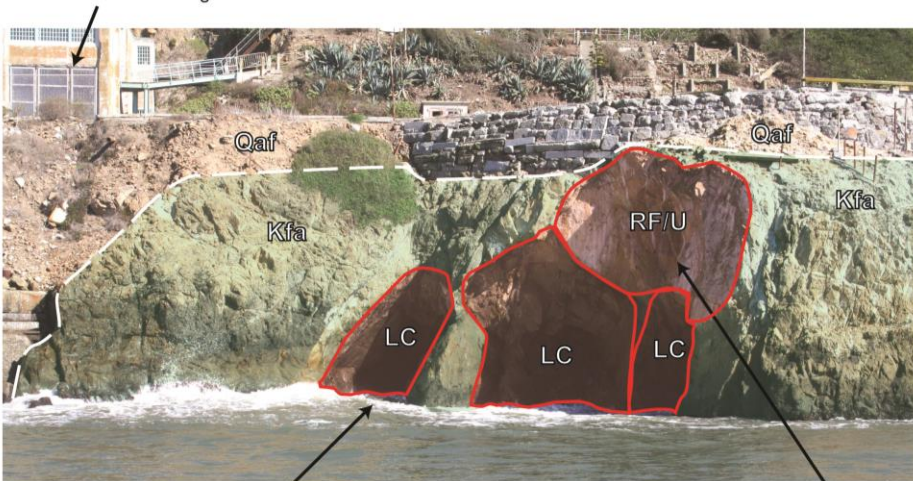
LC created by block and wedge failure along prominent joint sets.

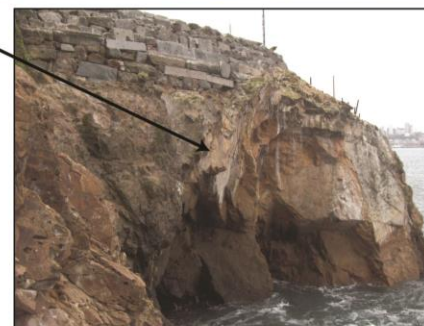
Undermined Rockfall Area

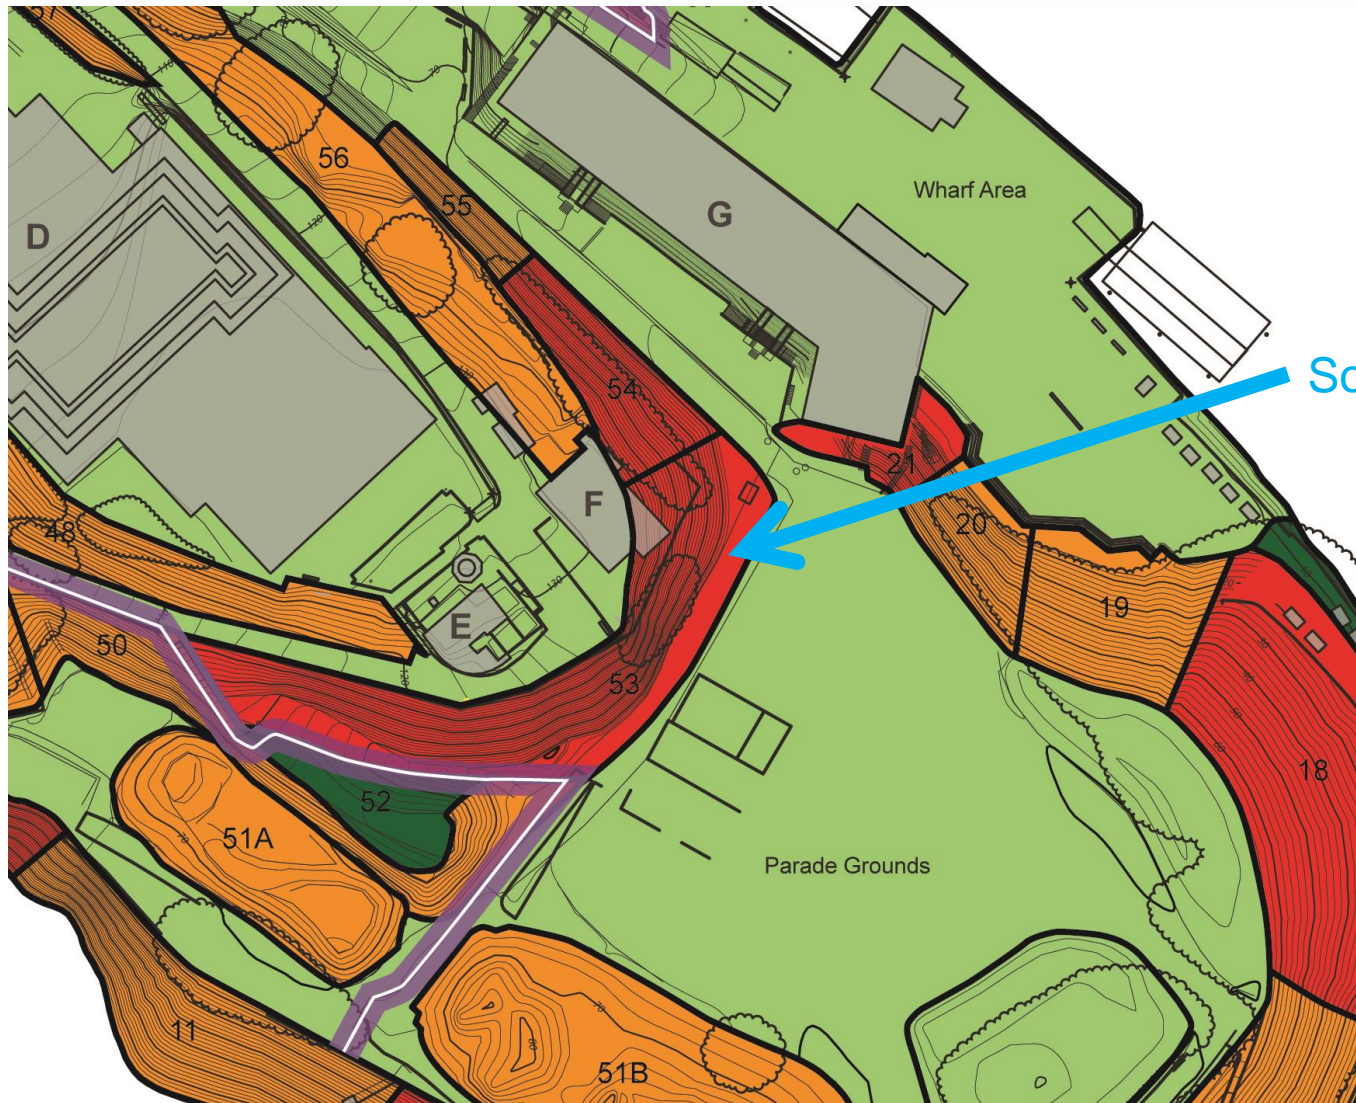
South Escarpment #53

EXAMPLE OF HIGH RISK

Active Rockfalls, undermining
improvements along entire top of
cliff

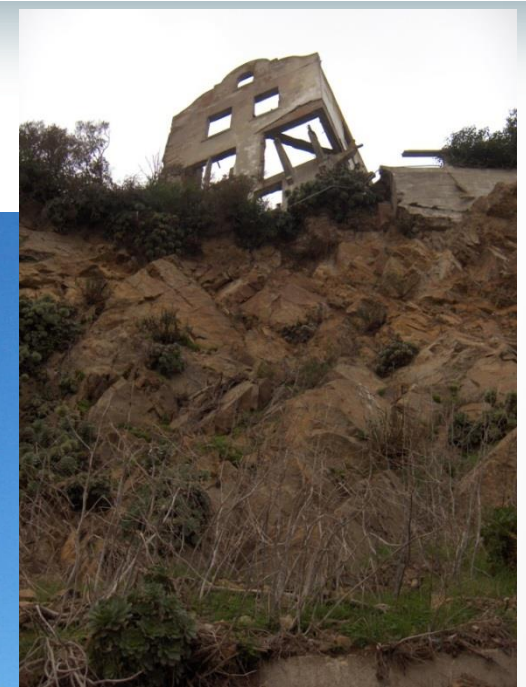
Close-up
of
Undermine
d Portion
of
Warden's
House

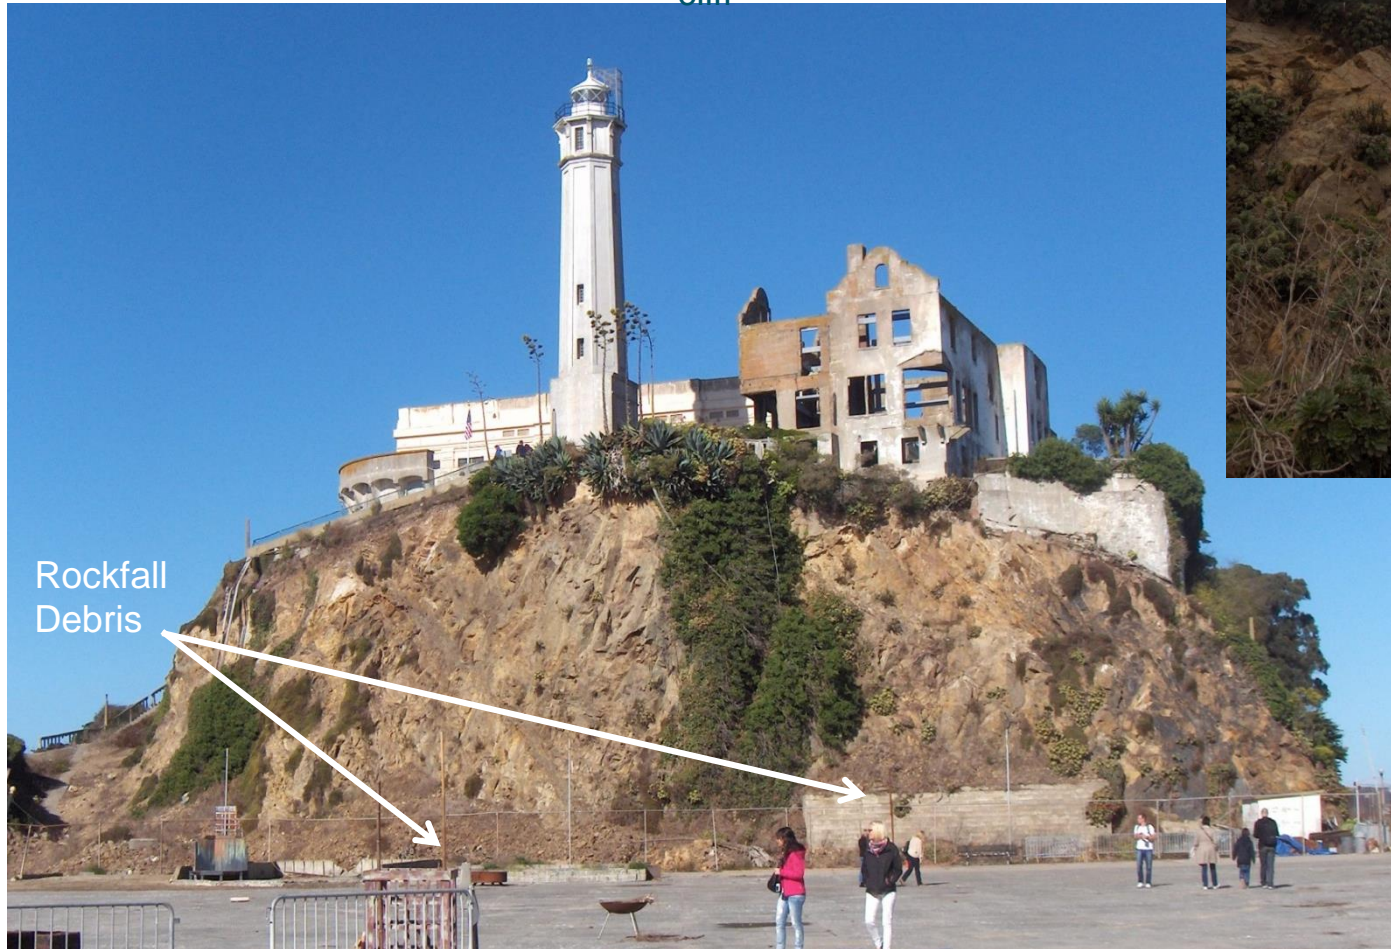
Rockfall
Debris

Public Access to Parade Grounds at Base of
Escarpment

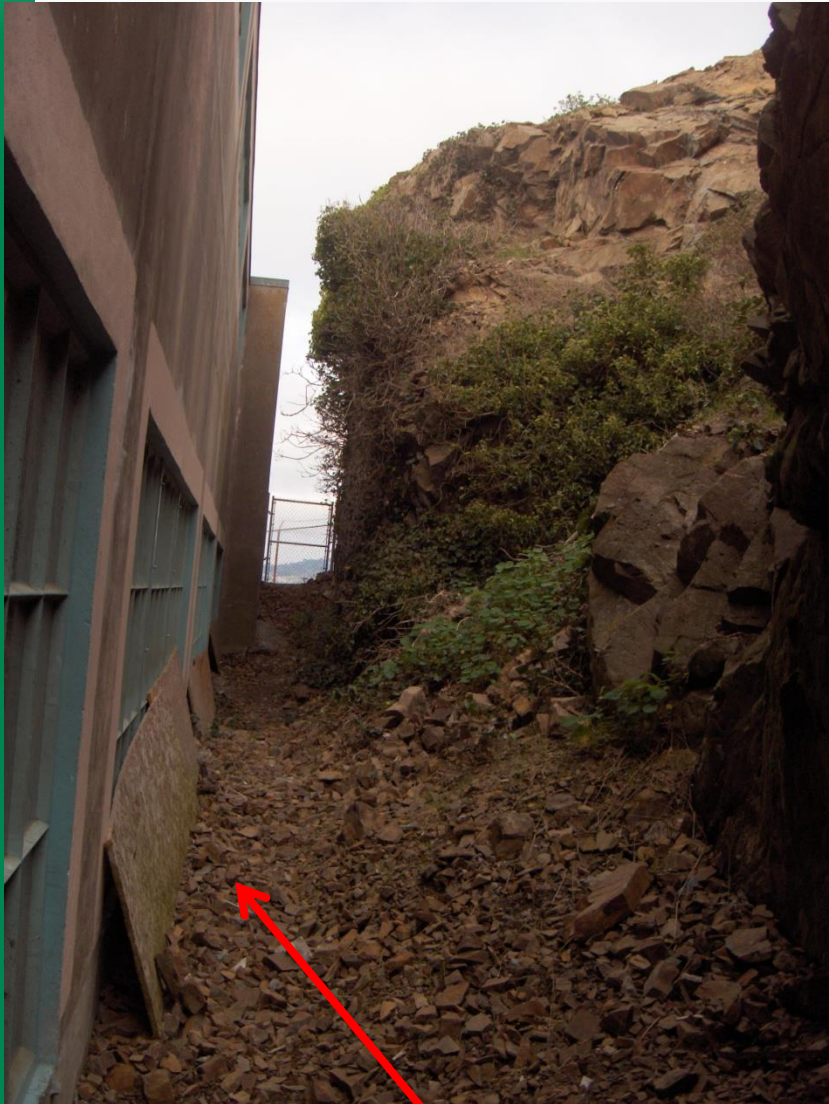
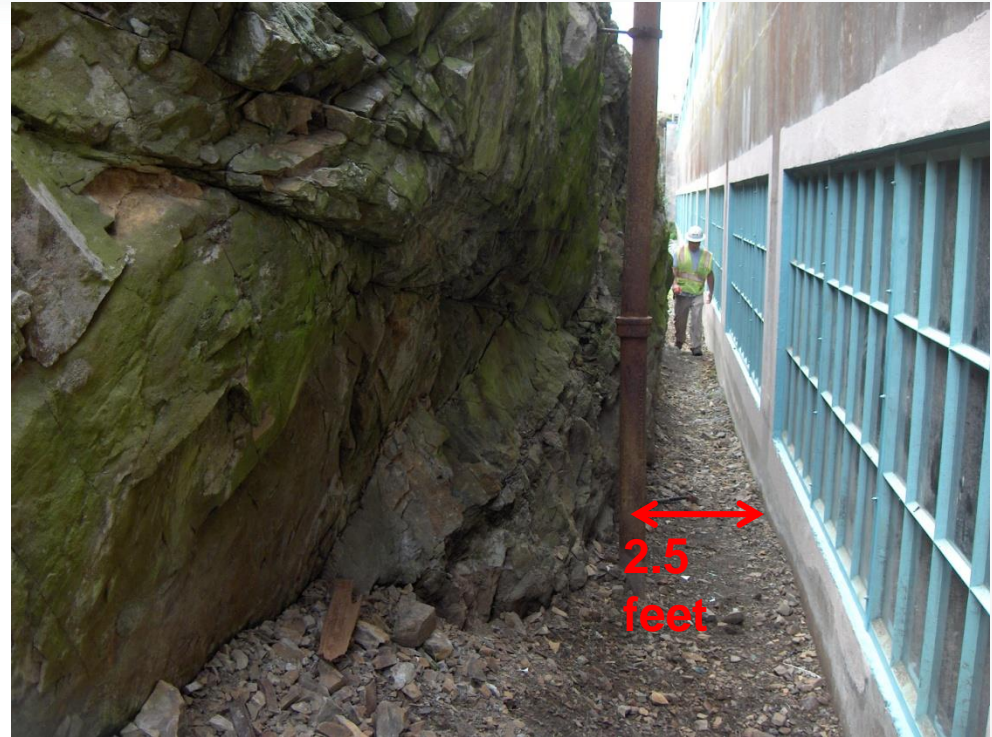
Vertical cuts in fractured rock, slope higher than the building

Active rockfall debris and plywood protection at windows
