How the Geoprofessional Avoided a Lawsuit and Saved the Owner \$6 Million!

Michael J. Byrne, Esq.
Byrne & O'Neill, LLP

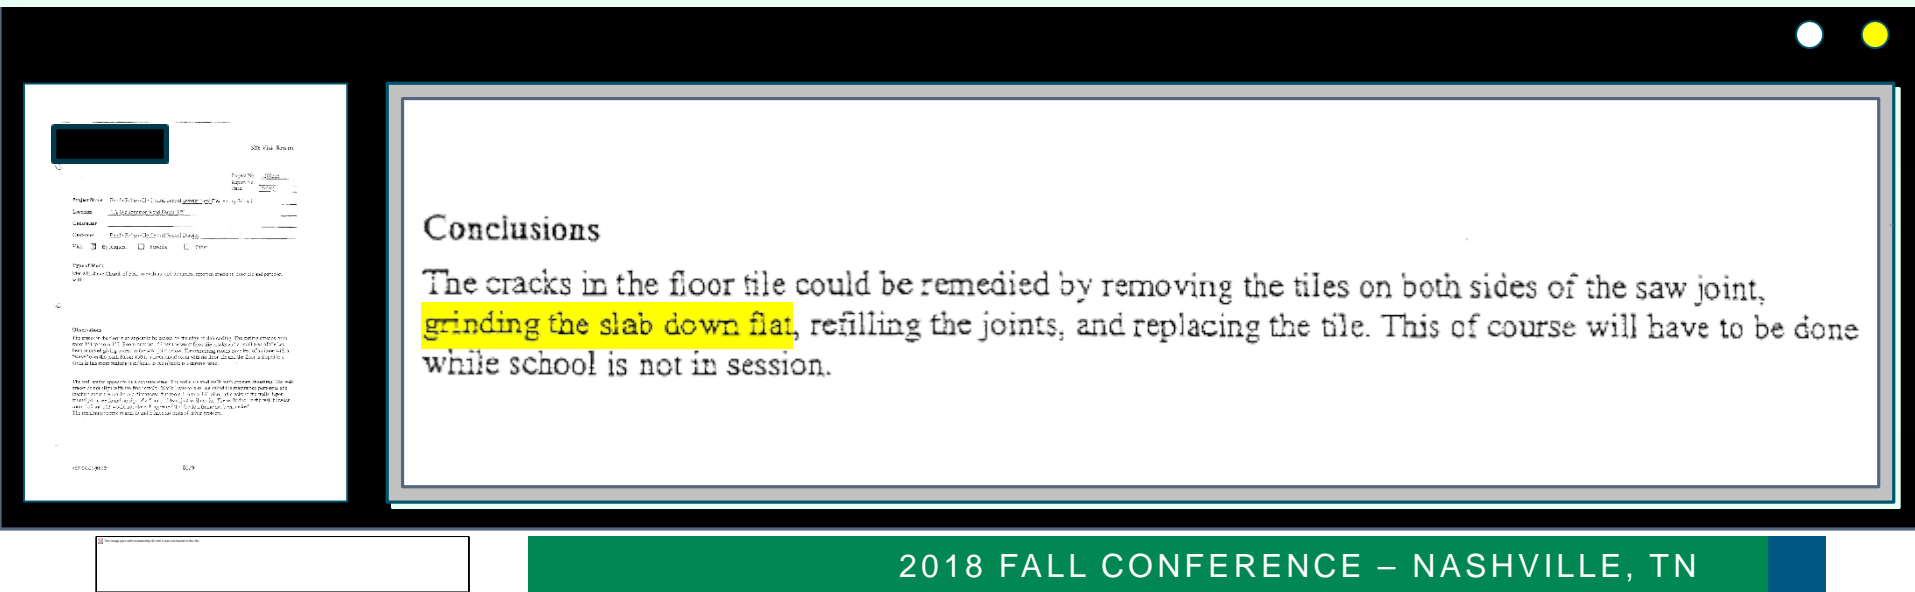
Survey at Saranac Showed Slab Heave, No Foundation Movement

Investigation Notes Slab Curling – R6

The cracks in the floor slab appear to be caused by the edge of slab curling. The curling extends from room 151 to room 157. Room number 154 has the worst floor tile cracks and a small area of tile has been removed giving access to the saw joint below. The remaining rooms have less of an issue with a “wave” over the joint. Room 150 is a mechanical room with no floor tile and the floor is sloped to a drain in this room making it difficult to see if there is a curling issue.

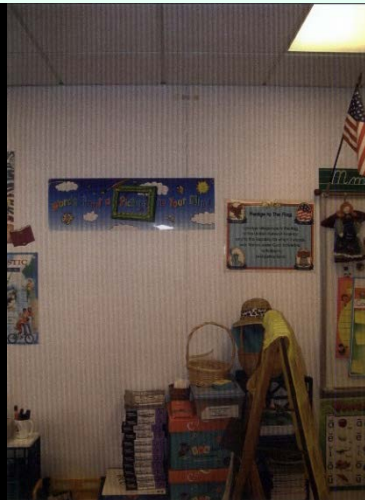
Photo Showing Cracks Wider at Ceiling – R11
