Friends Don't Sue Friends.....Most of the Time

**CASE
HISTORY** | NUMBER
105

Dan Schaefer, P.E.
Froehling & Robertson, Inc.

A Series of Unfortunate Events

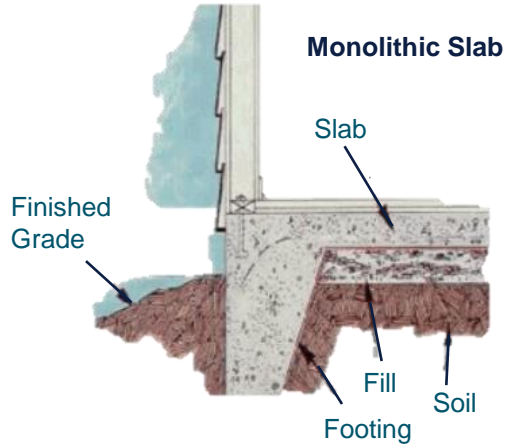
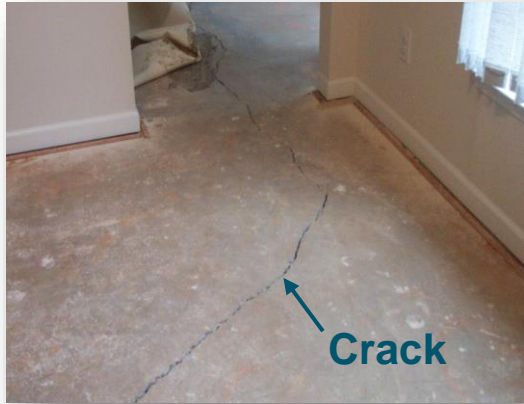
Slab Problems

- Unreinforced Monolithic Floor Slab
- Poor Design & Construction Practices
 - Design Restricts Shrinkage
 - Questionable Concrete Quality
 - No Curing & Late Jointing
 - Early Loading
- Random Plastic Shrinkage Cracks
- Known Widespread Issue
- Level Floor & No Structural Concern

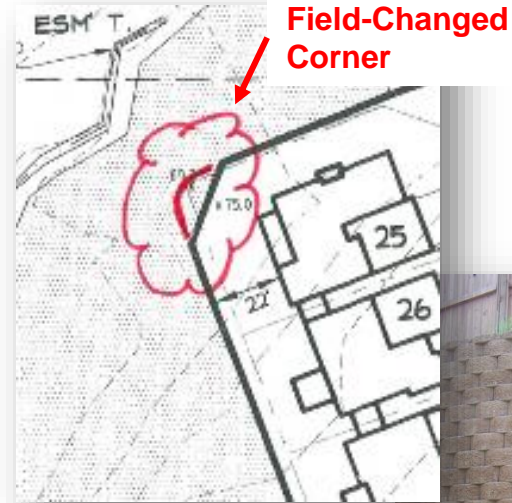
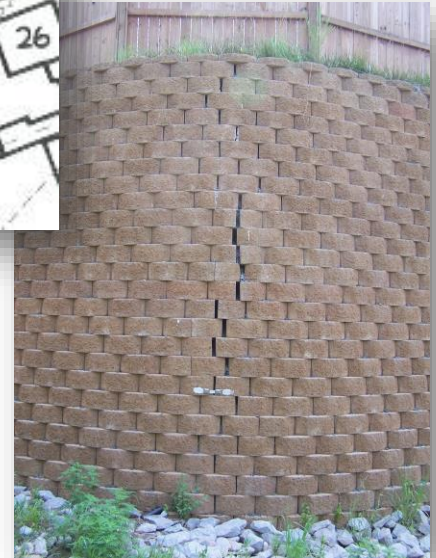
Wall Problems

- Wall Construction Went Well
- Field Change by Contractor
 - Angled Corner to Tight Radius
 - Block Cutting & Stacking Issues
 - Missing Pins & Grid Connectivity
 - Blocks Opened After Construction
- Change Not Approved by Designer
- Reported as Discrepancy by Technician
- NOT Communicated by PM
- No Other Signs of Movement or Distress

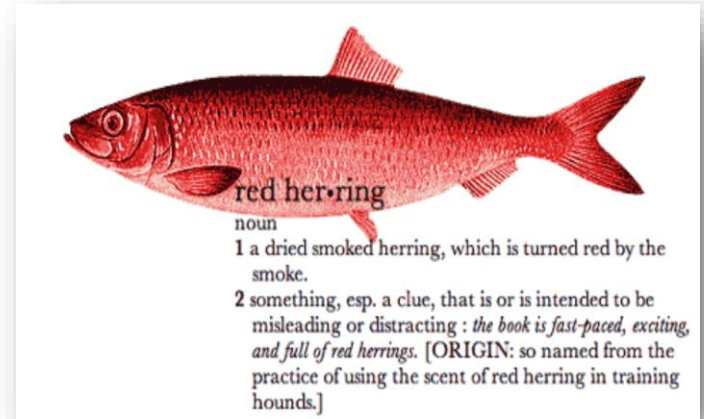
The Red Herring

- Homebuilder Hired Expert
- Concluded Cracks in House Caused by Lateral Wall Movement and Slab Settlement
- Data Did Not Support Conclusion
- Mislead by Crack in Wall
- Recommended \$400,000 Repair
- Widespread Disagreement by Other Experts
 - Wall Cracks were Just in Façade
 - Slab Cracks from Plastic Shrinkage
