Selway Slide Emergency Repair

Travis J. Wambeke, P.E., P.G.

GeoProfessional Innovation Corporation

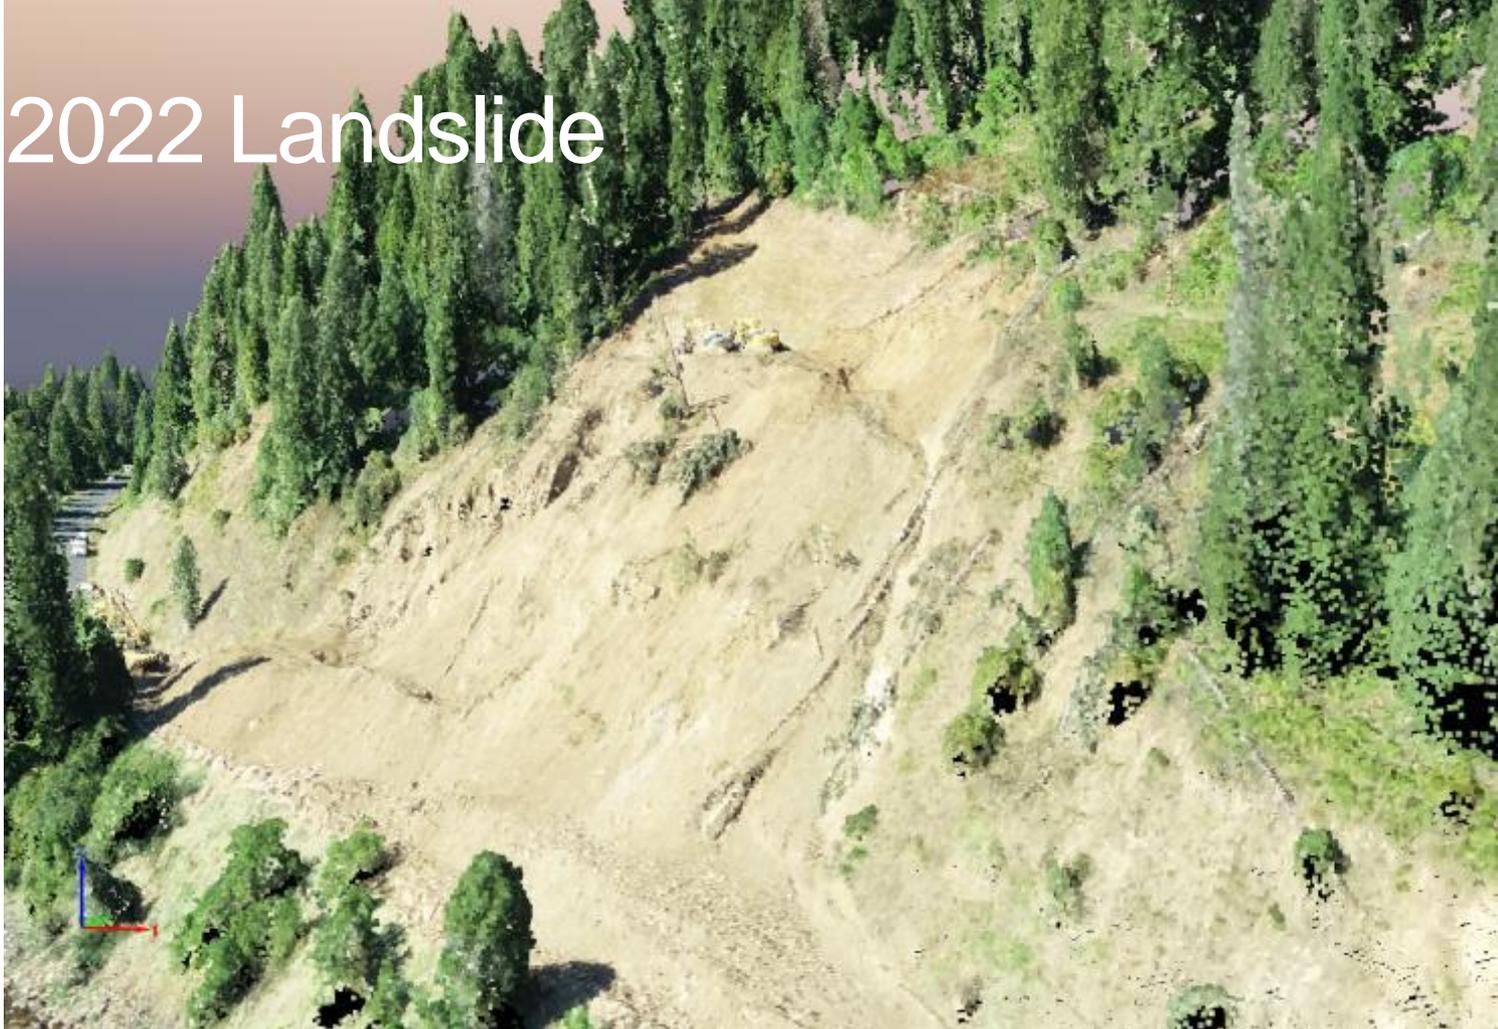
July 15, 2022 Landslide

- 30' debris field on roadway
- 500' of blocked roadway
- 90,000+ yd³ soil and rock
- Blocked critical access for firefighting, material supplies, public & private access

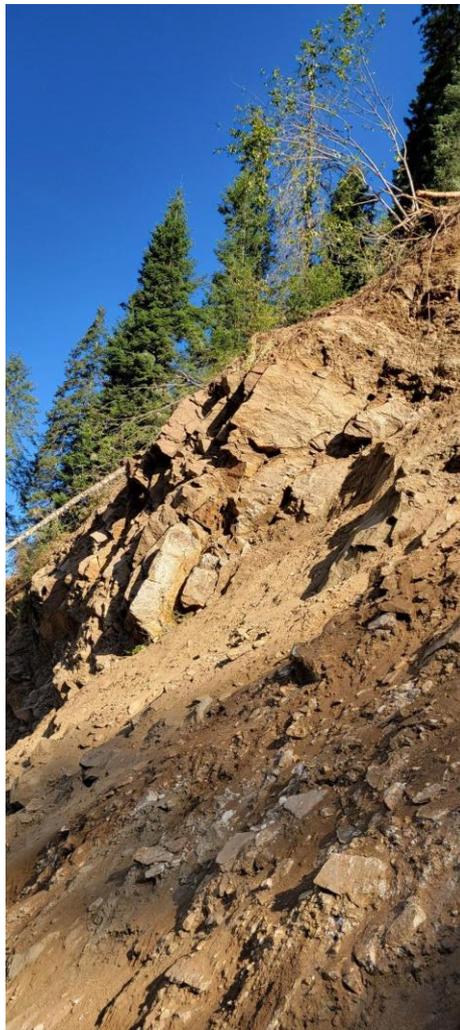
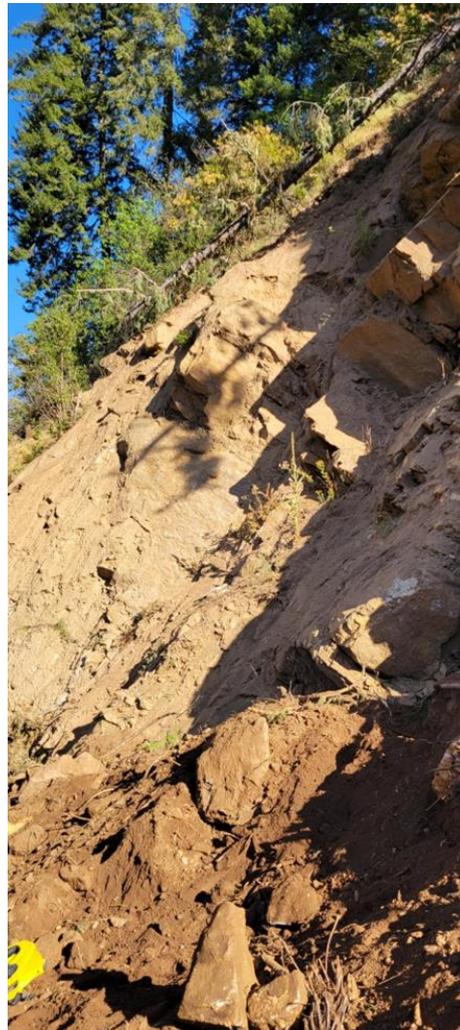
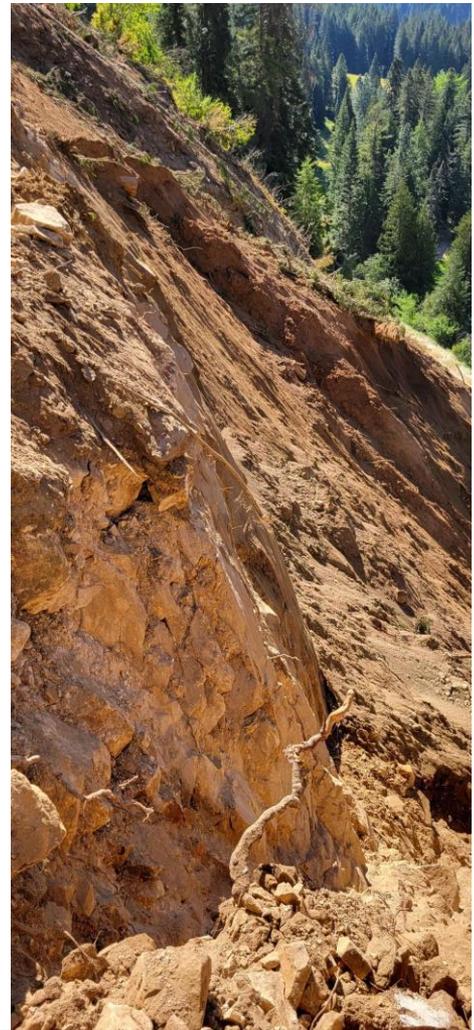
The Culprit: Rhyolite Dike

- Vertical scarps in areas
- Wedge failure planes dipping towards roadway
- Progressive plane shear failure
- Instigated circular failure in residual soil

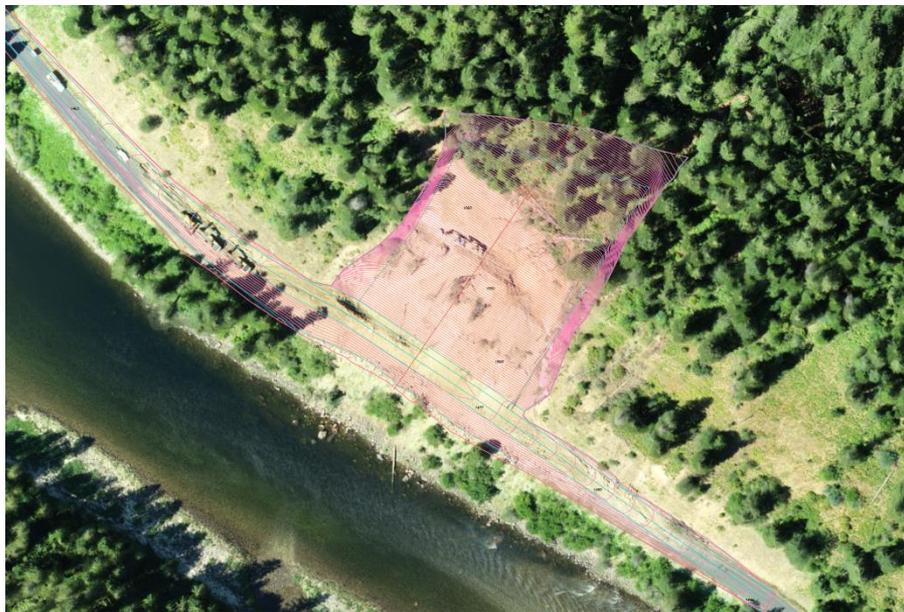
Aerial topography of landslide extents

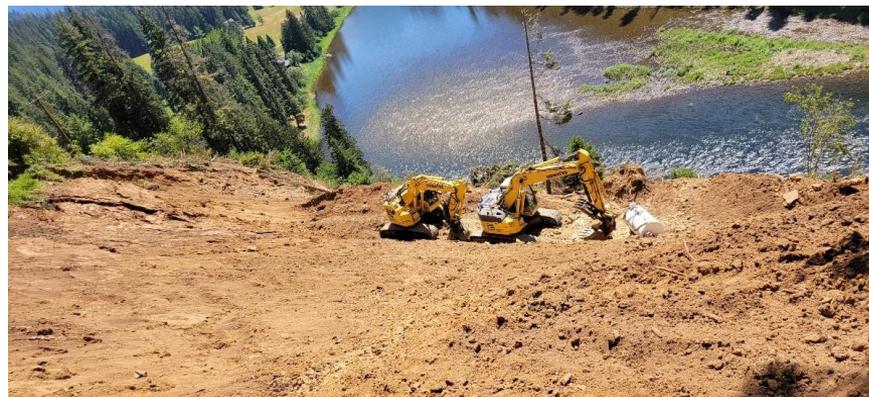
Staged equipment just prior to secondary soil slope failure

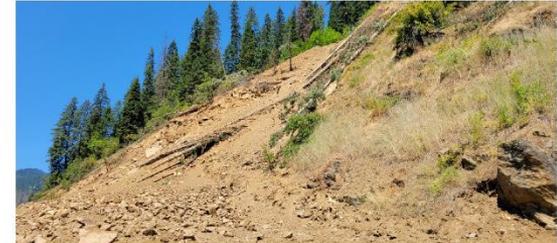
Photograph 1: From Existing Roadway, South Flank

Approximately 300 linear feet of the existing roadway alignment is completely blocked with rock and soil landslide debris mixed with isolated logs and vegetation. Landslide debris has not been substantially manipulated by Debco and has been deposited to approximately 12 to 15 feet high above the Selway River Road surface by at the midpoint of the failure. A few large boulders reached the Selway River estimated to be 50 feet below the road grade. However, no visual evidence of toe bulging or sub-road grade failure was evident at the time of our site visit.

The undisturbed section of the roadway is relatively straight with a shallow grade (2% to 3%). The outboard (west) roadway slopes are steep, 1H:1V (horizontal to vertical) fills down to the Selway River. The inboard (east) side of the roadway expose ½H:1V to ⅓H:1V rock cut slopes over 100 feet in height. Exposed bedrock comprised moderately to highly weathered, medium to coarse grained, biotite granodiorite weathered and metamorphosed to gneiss and schist that was moderately fractured with smooth to rough, block-type joint patterns. Reference the Geology section of this memorandum for a more detailed discussion of the mapped geology in the slide area.
