## **Limiting the Fallout: A Proactive Response to a CoMET Snafu**

**Chuck A. Gregory, P.E.  
Terracon Consultants, Inc.  
Senior Principal  
Vice President  
Regional Manager  
San Antonio, Texas**

# The Project

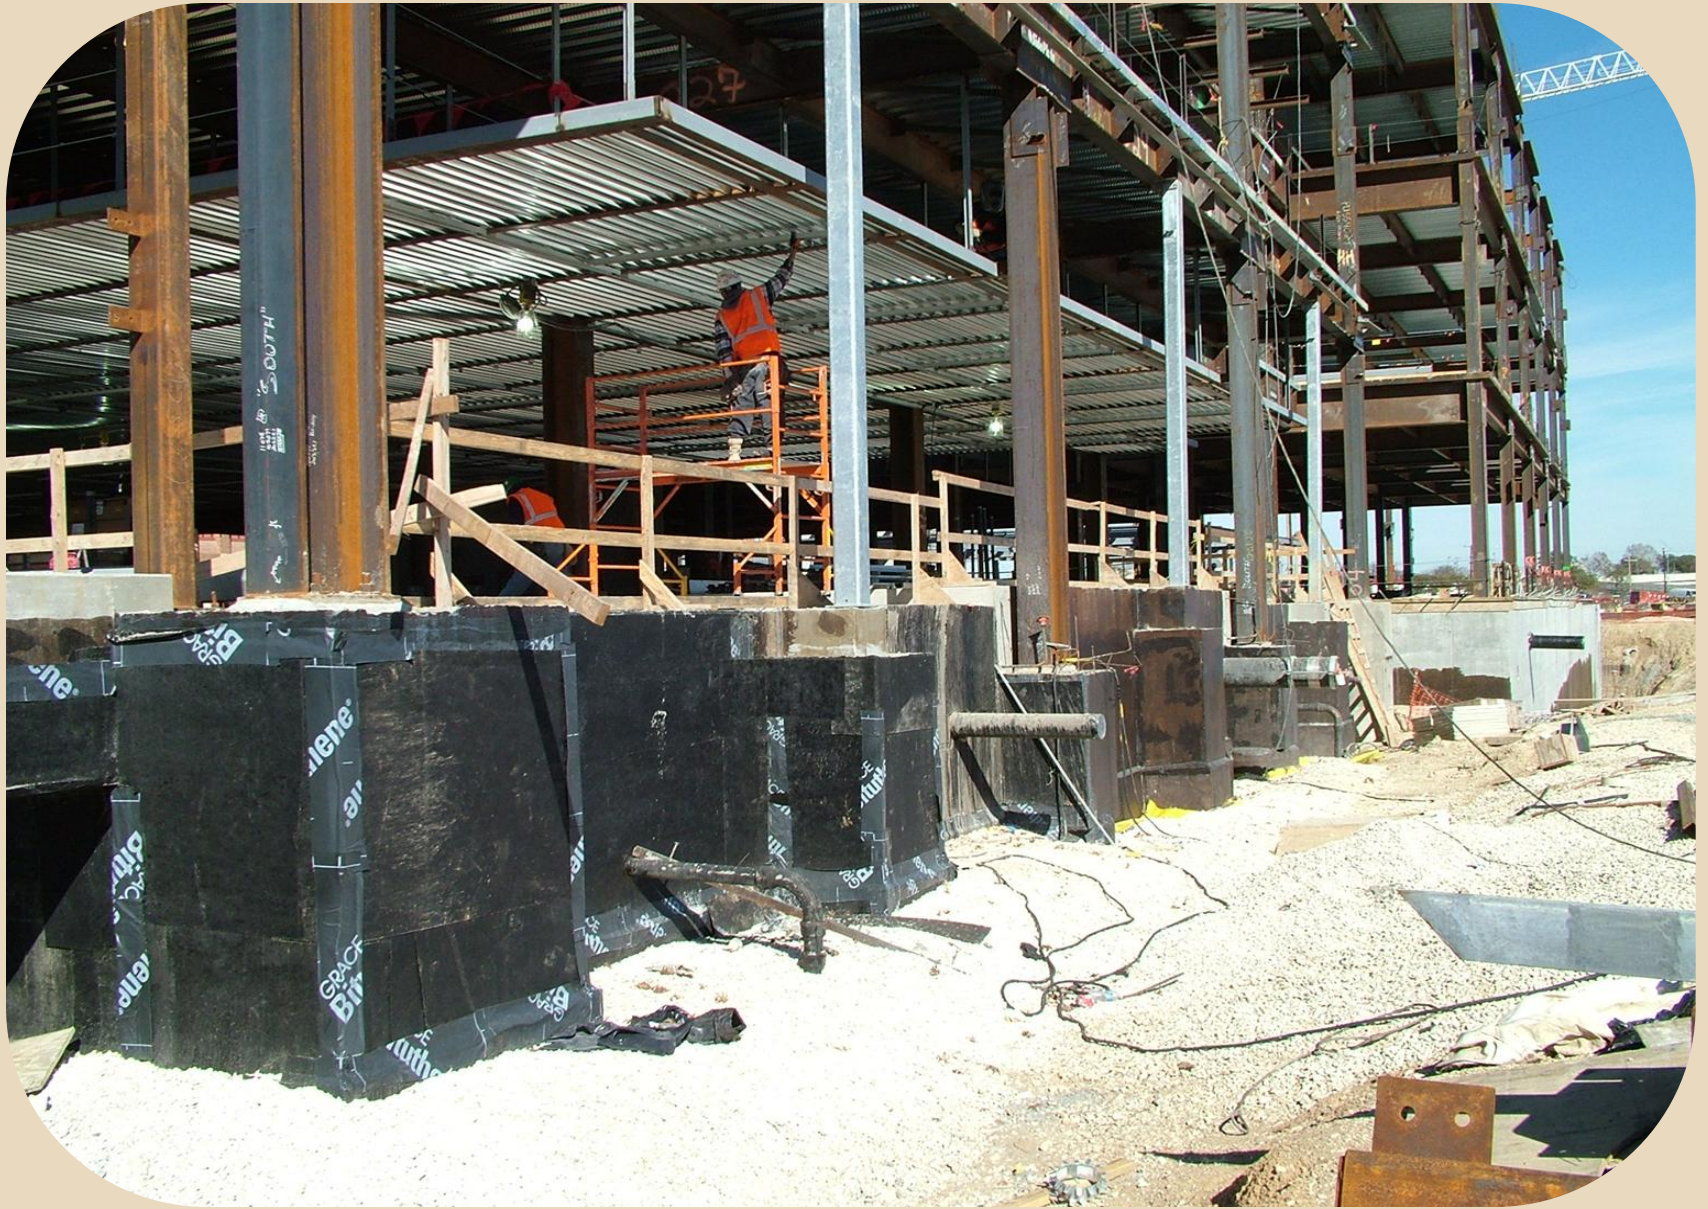
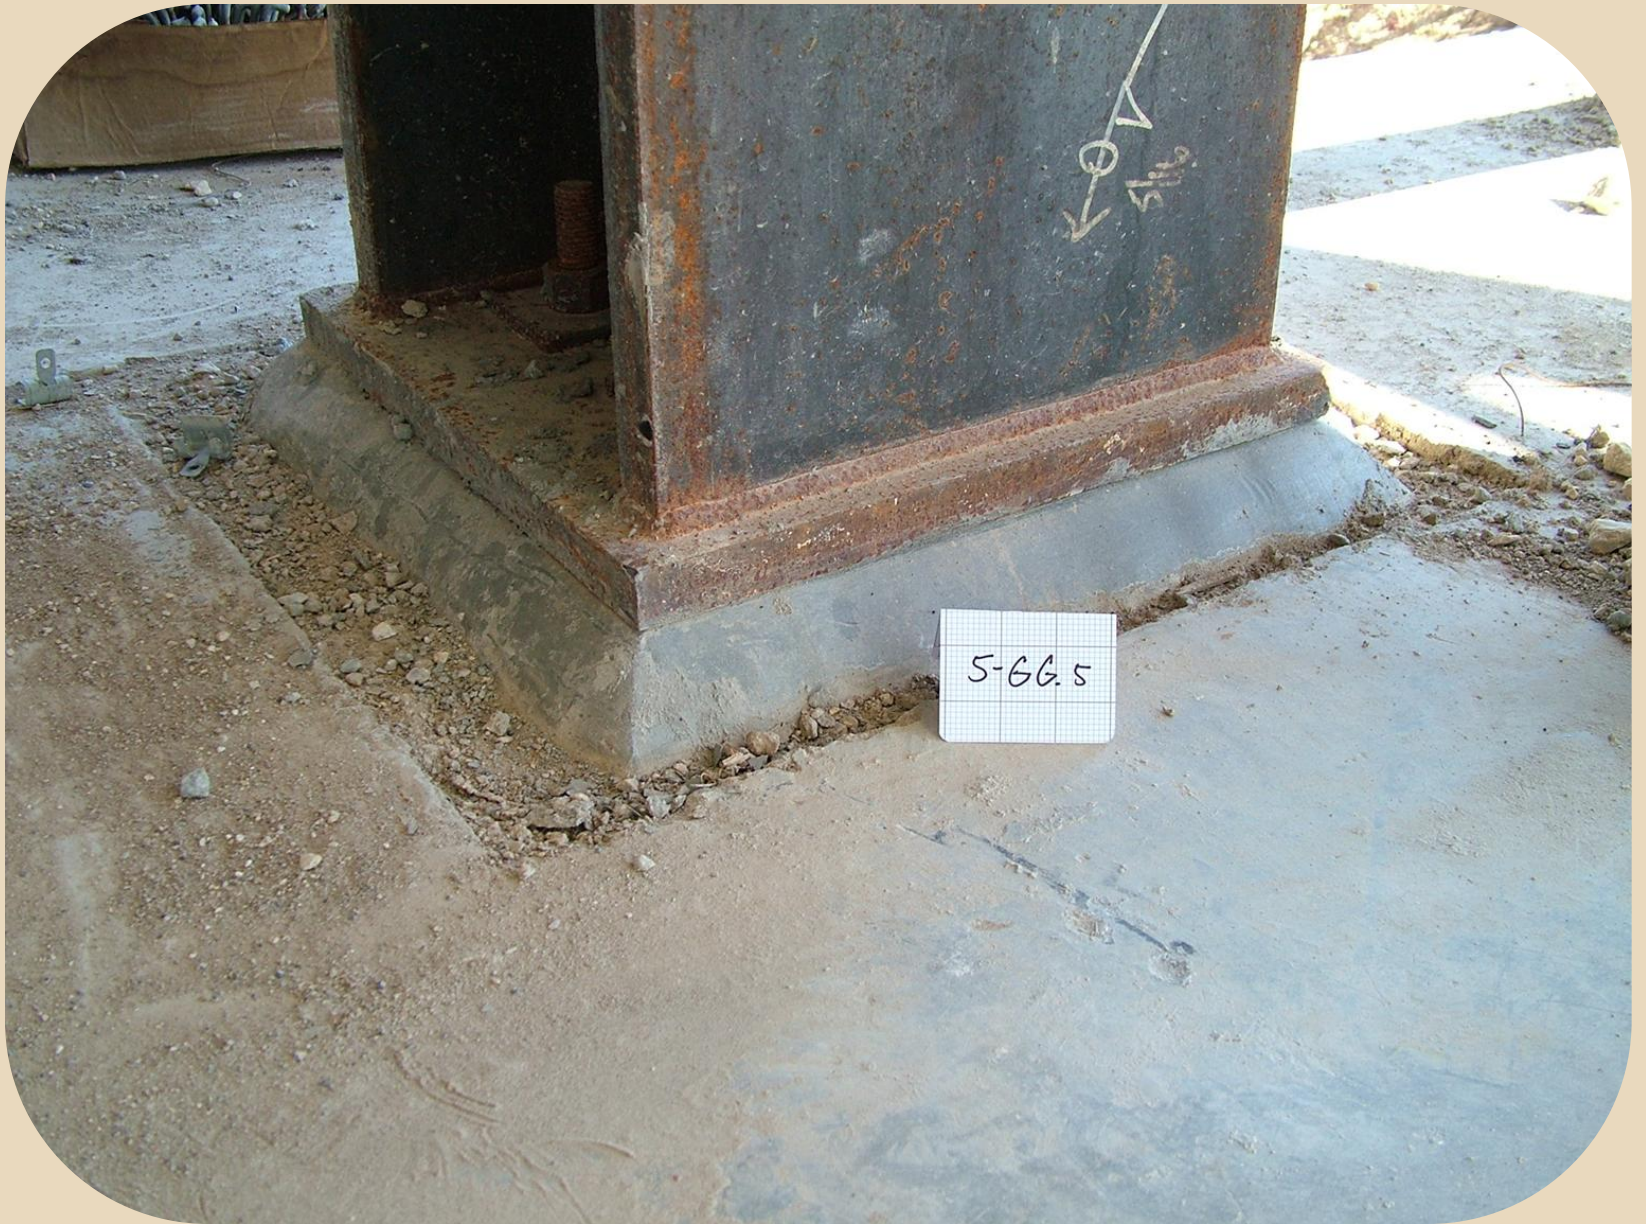
- Non shrink (expansive) grout
- Bagged product
- Mixed on site
- Hand placed beneath column base plates
- Submittal Information
  - 8000 psi minimum at 28 days
  - 2x2x2 inch cubes
  - ASTM C109 Modified; C1107

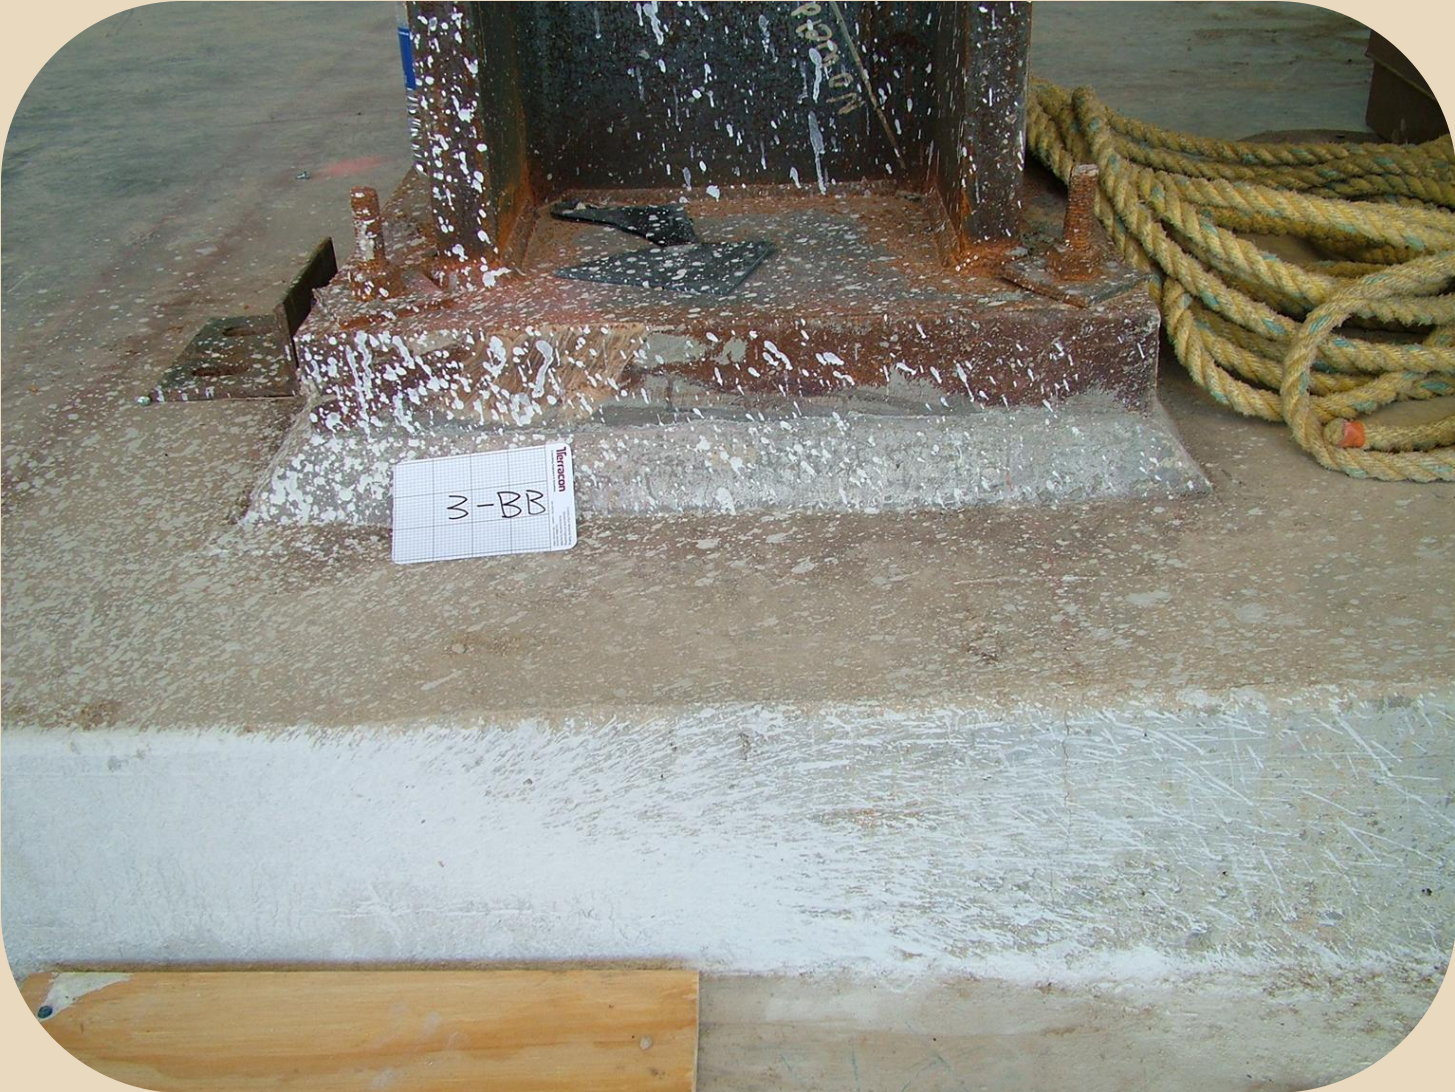
# CONDITION 1

# Condition 1 – With Grout Overbuild

- Remove portion of the triangular shaped overbuild
  - Cut to form cubes/cores
  - Expected lower strength than beneath grout base plate
  - Overbuild would not be replaced
- 
- **Client: Granted permission to sample Condition 1 locations**

- Trimmed field samples to 1:1:1 Ratio
- Sealed in plastic bags 5 days
- Weigh, measure, cap, test
- 15 of 17 sets exceed 8000 psi
- Other 2 sets exceeded 85% of 8000 psi

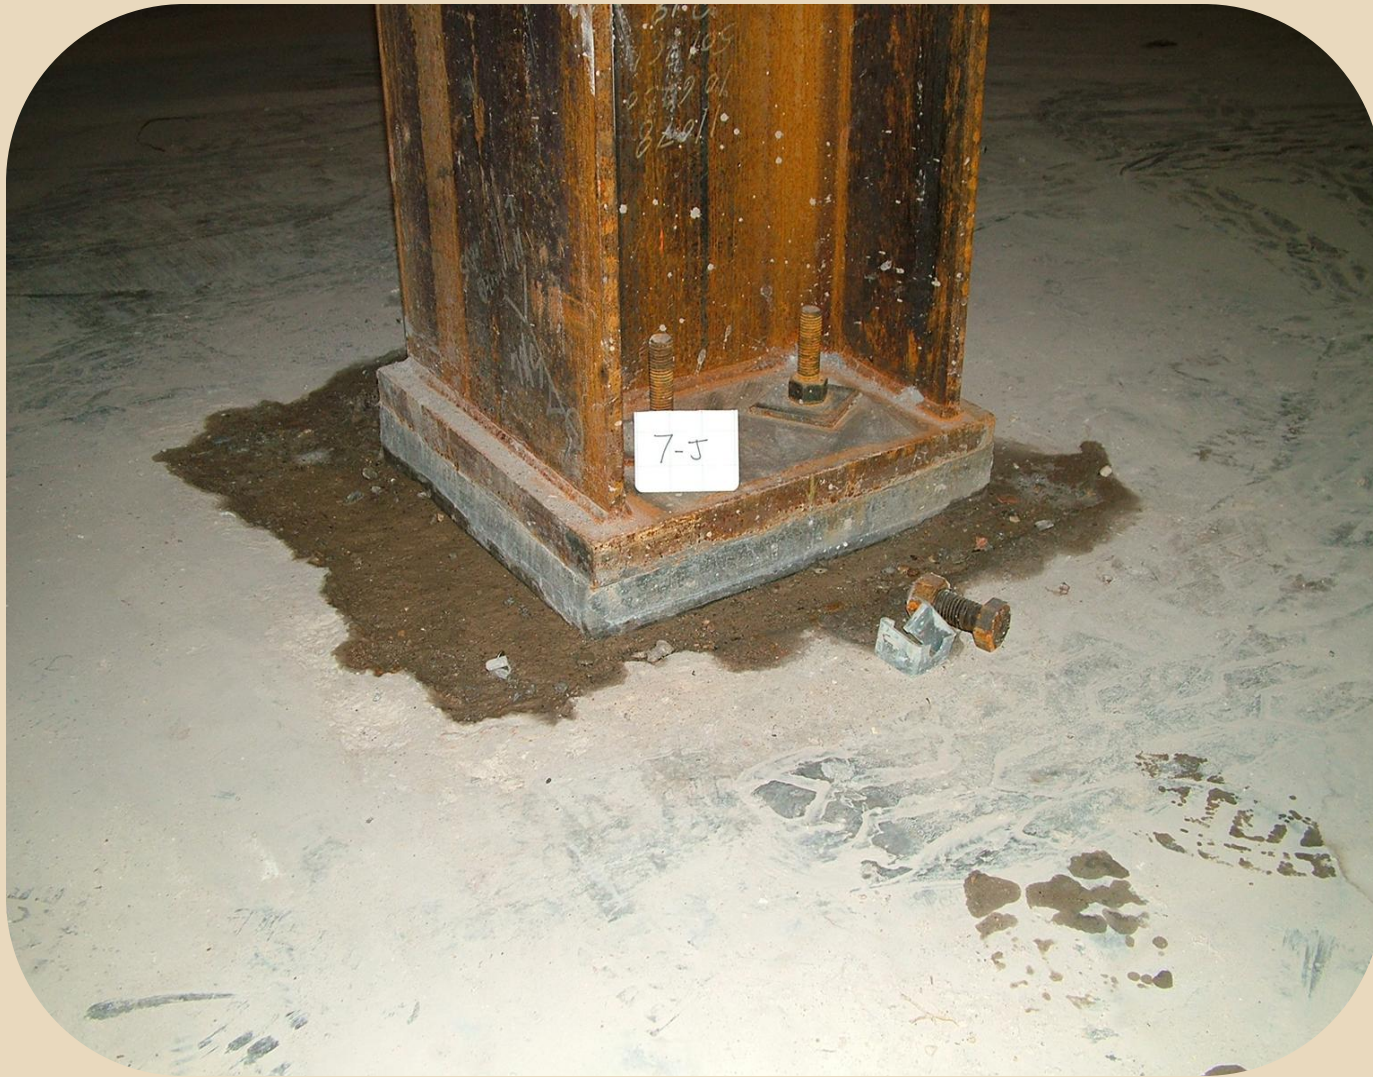
# CONDITION 2

# Condition 2 – No Grout Overbuild

- Locate shim packs
- Core Grout – Method A, B, C
  - Method A
    - Center of base plate
    - Core base plate and grout
    - Patch hole with grout
    - Reflects confinement
    - Same Test Orientation with Respect to Confinement
    - Near neutral axis of base plate

- Method B

- Core grout horizontally
- 1/3 to 1/2 dimension of base plate
- Orientation differences – Lower strength than Method A

- Method C

- Drill, saw, chip grout from beneath base plate
- Prepare test specimen
