A closer look at the Alaskan Way Viaduct Replacement Program

David Sowers

AWV Deputy Program Administrator
Engineering and Program Management

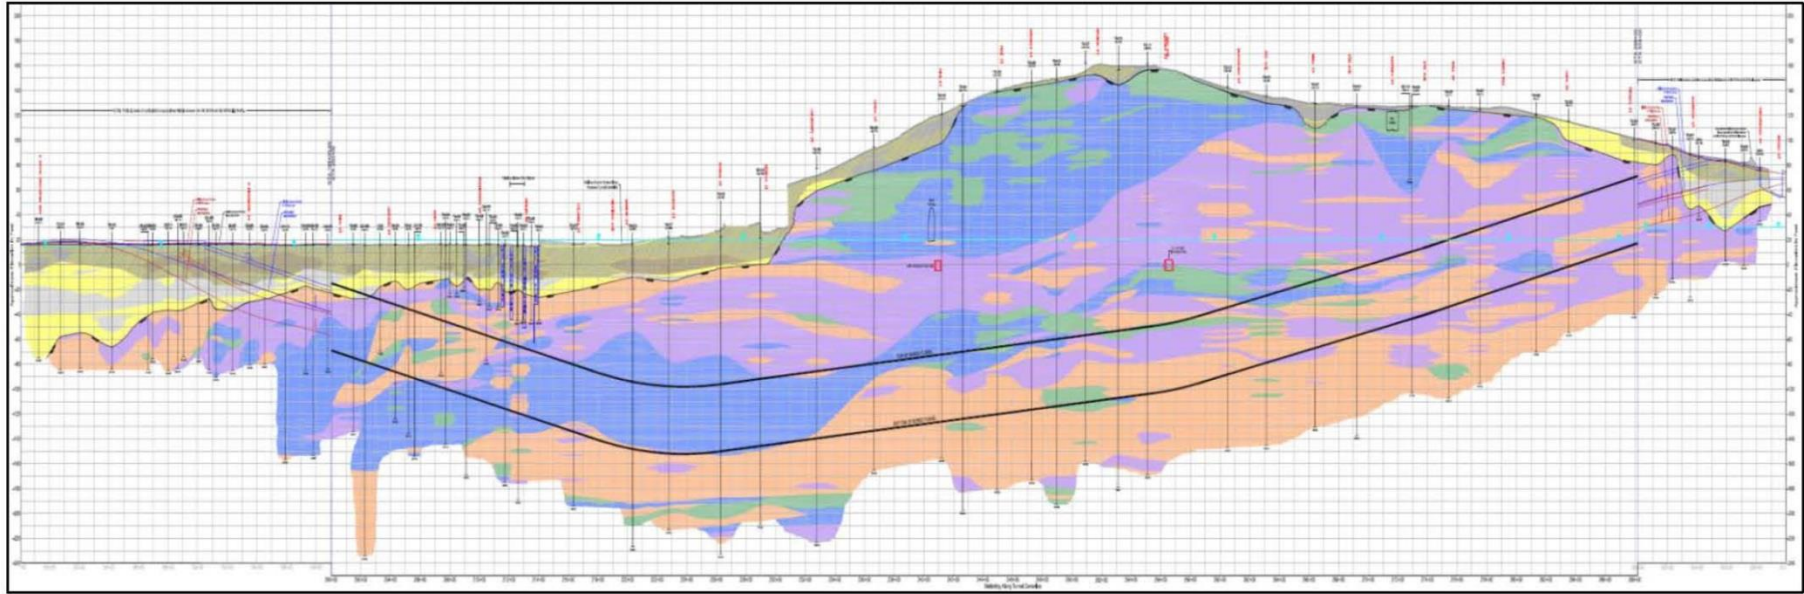
Baseline geologic

RECENT GRANULAR DEPOSITS:
Loose to dense SILT and SAND with gravel; includes normally consolidated alluvium, granular fill, beach deposits, reworked glacial deposits, and recessional ice-contact deposits.

RECENT CLAY AND SILT:
Soft to very stiff CLAY and SILT with fine sand beds; includes normally consolidated cohesive fill, estuarine deposits, and recessional lacustrine deposits.

PEAT AND WOOD:
Very soft to hard PEAT, silty PEAT, organic SILT and WOOD; includes fill, normally consolidated peat and overconsolidated peat and buried soil deposits.

TILL:
Dense to very dense, silty SAND and GRAVEL, and hard, silty CLAY with sand and gravel; cobbles and boulders are common in these deposits; includes glacially overconsolidated till and glaciomarine drift.

TILL-LIKE DEPOSITS:
Dense to very dense, silty SAND and GRAVEL, and hard, silty CLAY with sand and gravel, interbedded and intermixed with cohesionless sand and gravel; cobbles and boulders are common in these deposits; includes lenses and layers of glacially overconsolidated till and glaciomarine drift.

COHESIONLESS SAND AND GRAVEL:
Very dense SAND and GRAVEL to SAND with variable silt; cobbles can be found in these deposits; includes glacially overconsolidated fluvial and glacial outwash deposits.

COHESIONLESS SILT AND FINE SAND: Very dense SILT, silty fine SAND, and fine sandy SILT with trace of clay; predominantly cohesionless; includes glacially overconsolidated lacustrine deposits.

COHESIVE CLAY AND SILT:
Very stiff to hard, silty CLAY and clayey SILT with trace of sand and gravel; scattered cobbles and boulders can be found in these deposits; includes glacially overconsolidated lacustrine, peat, and paleosol deposits.

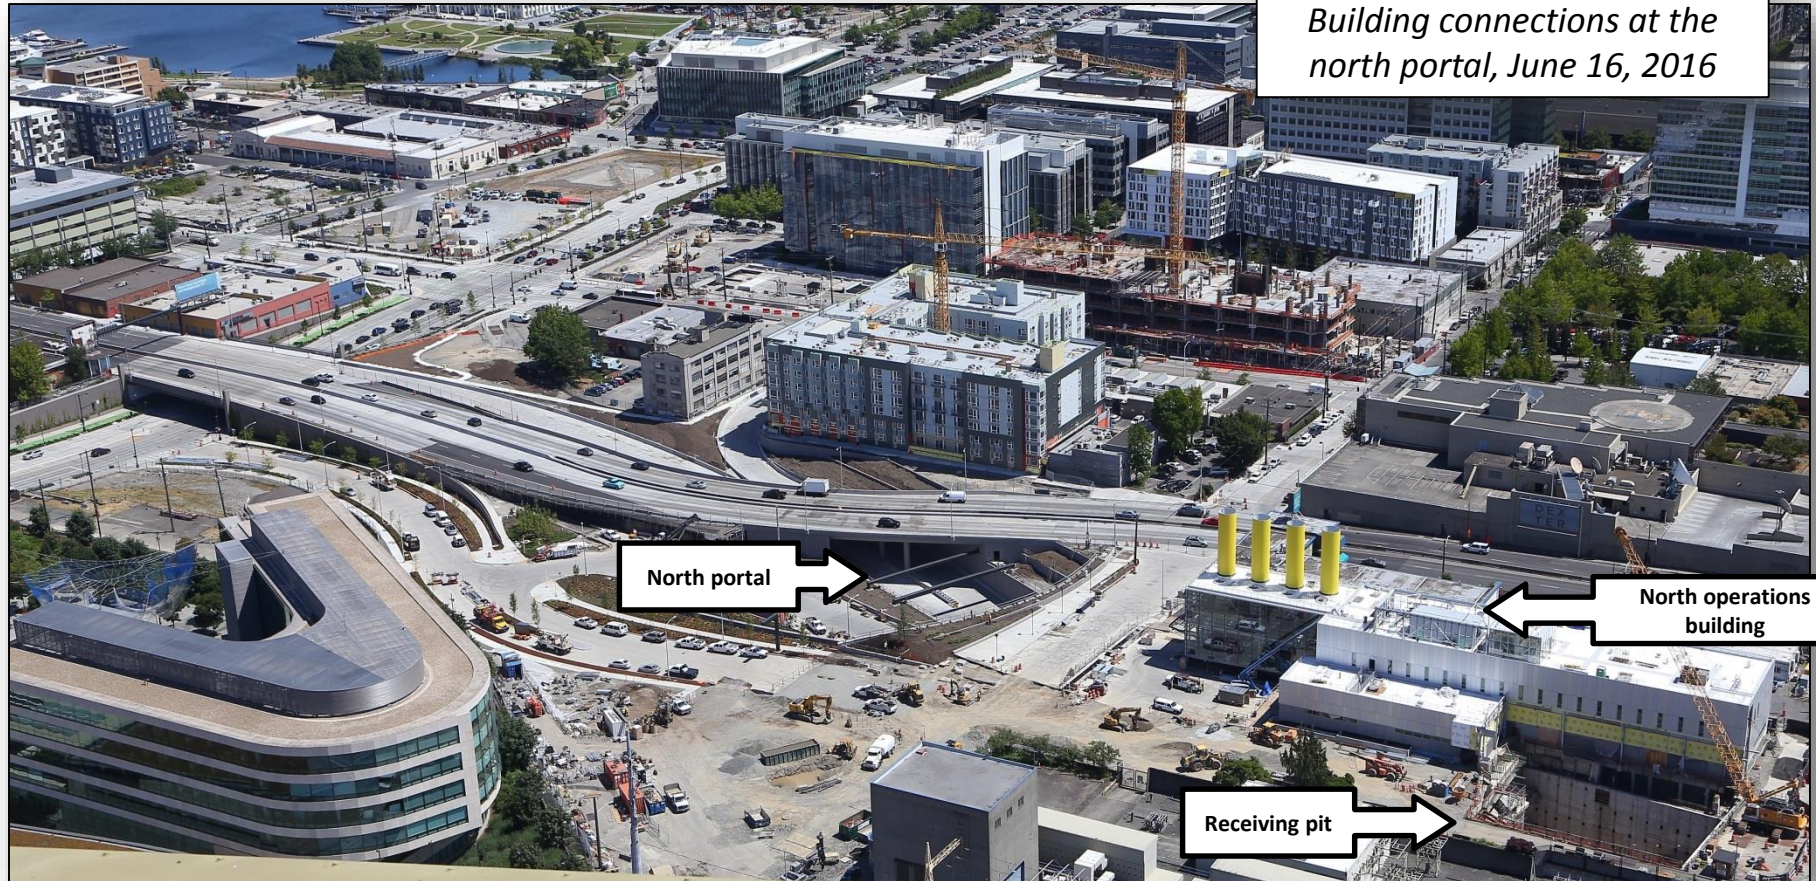
*Building connections at the
north portal, June 16, 2016*

North portal

North operations
building

Receiving pit

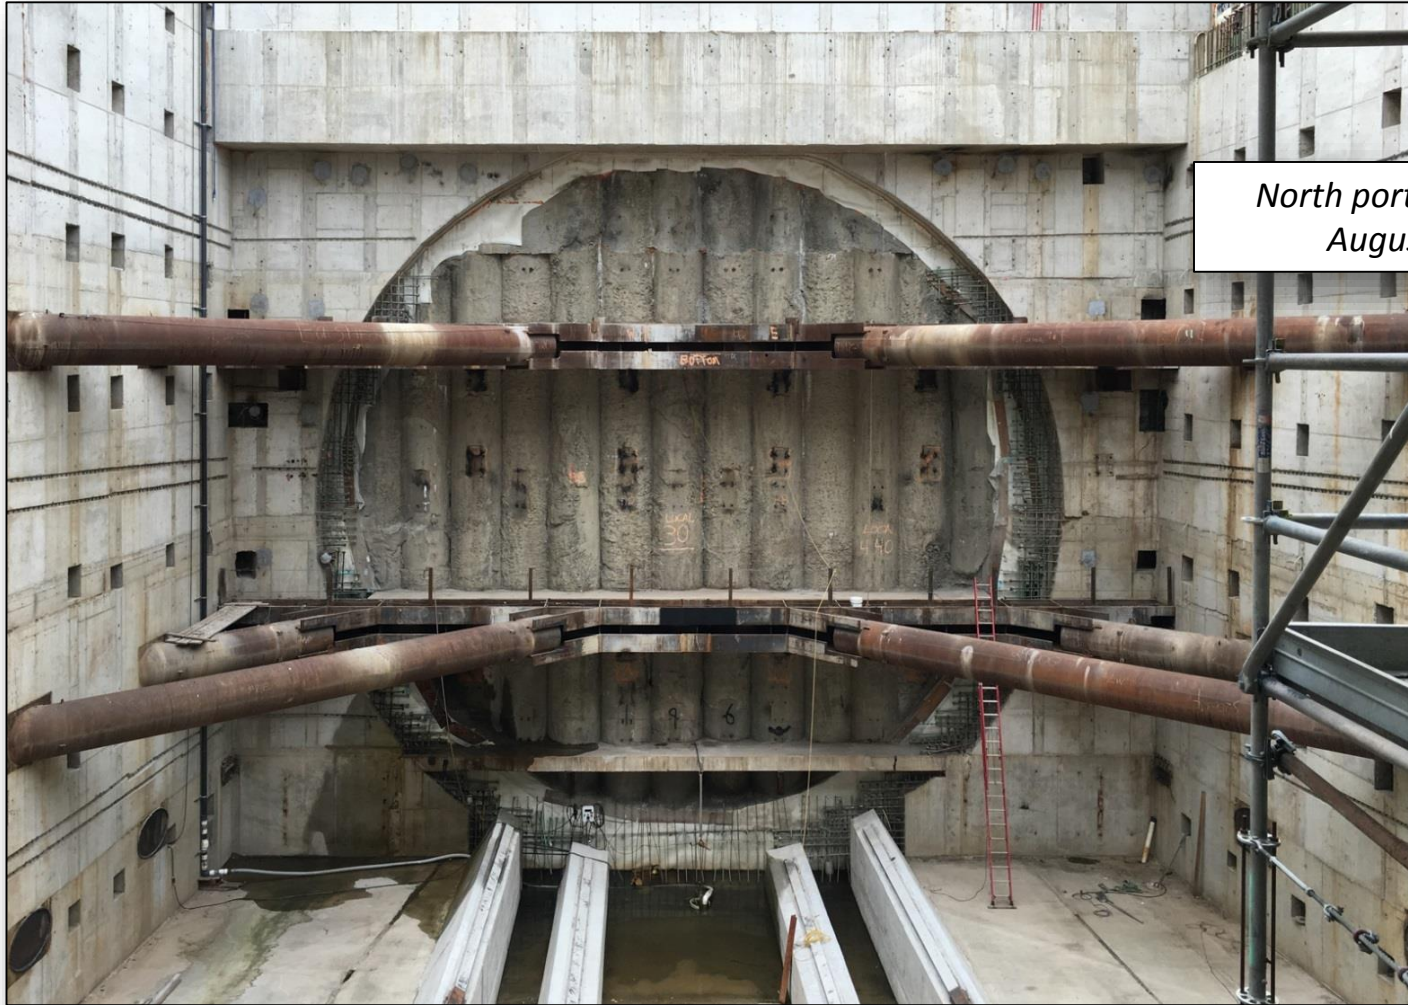
*North portal receiving pit,
August 31, 2016*

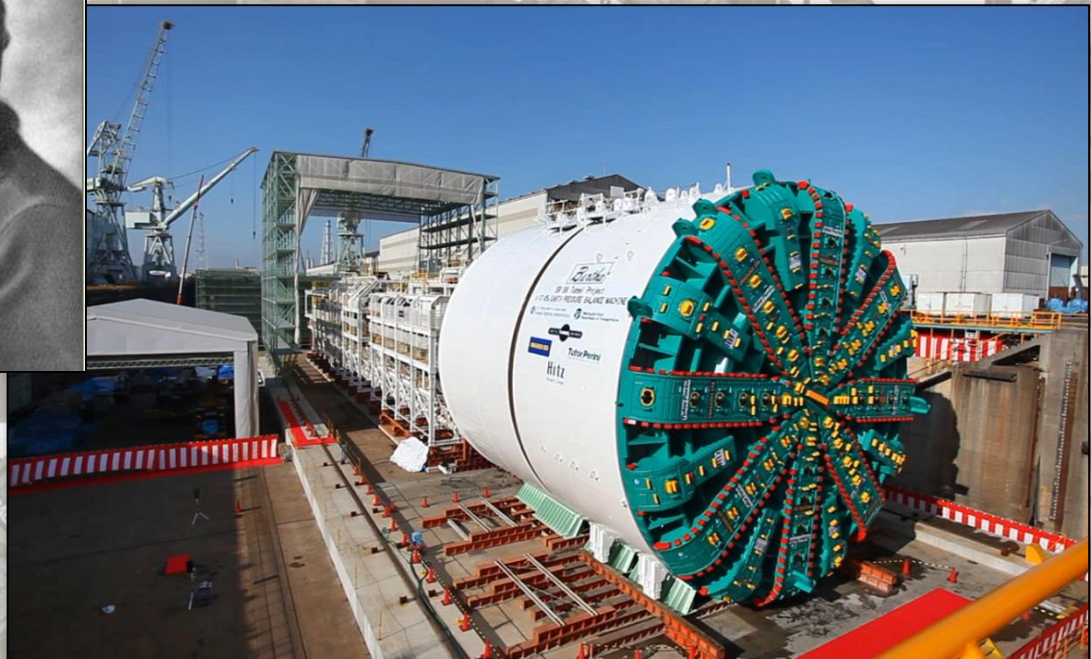
Vital stats:

- 57.5 feet in diameter
- 326 feet long
- Nearly 7,000 tons

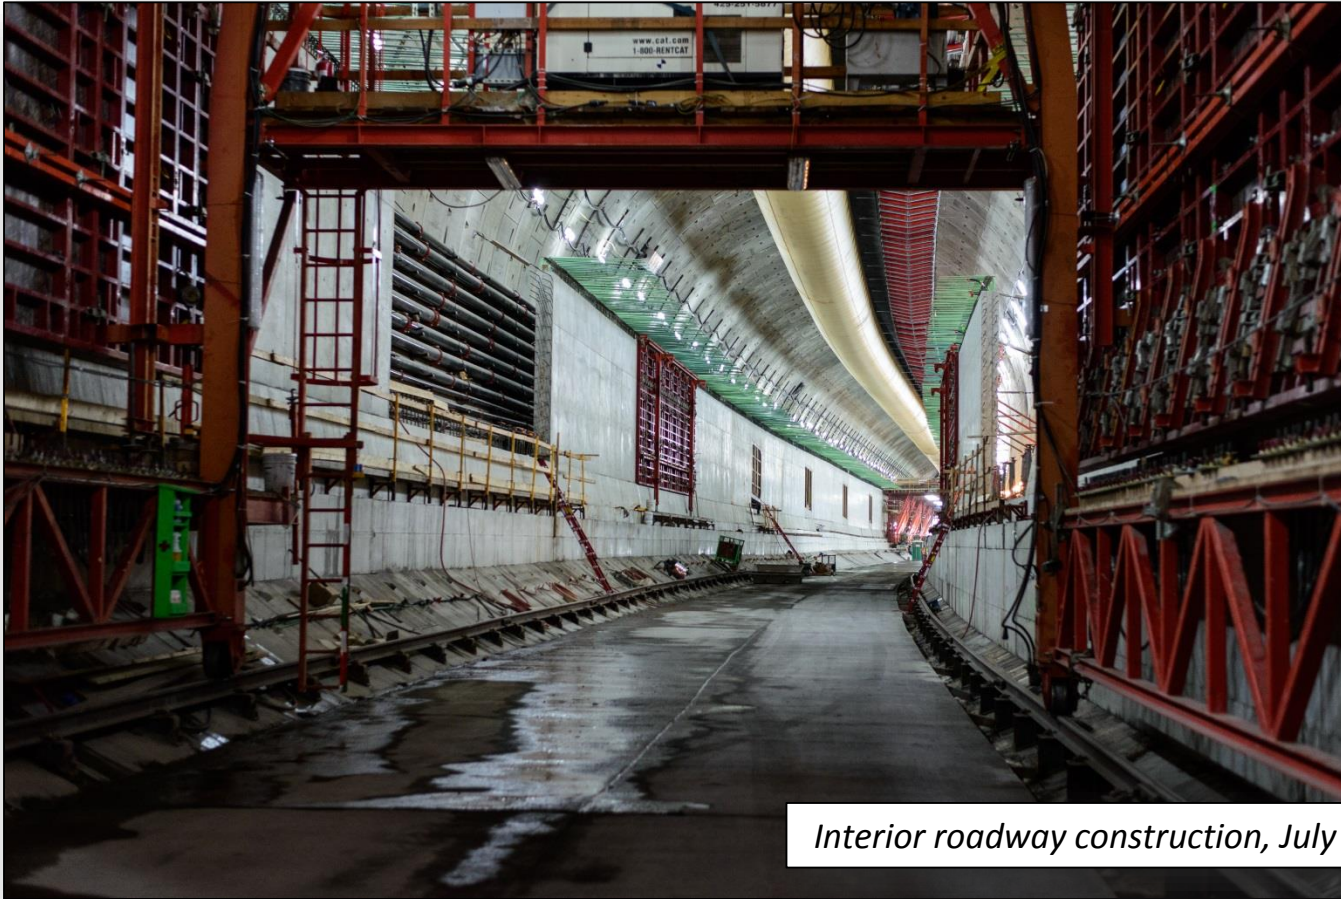
Interior roadway construction, July 13, 2016

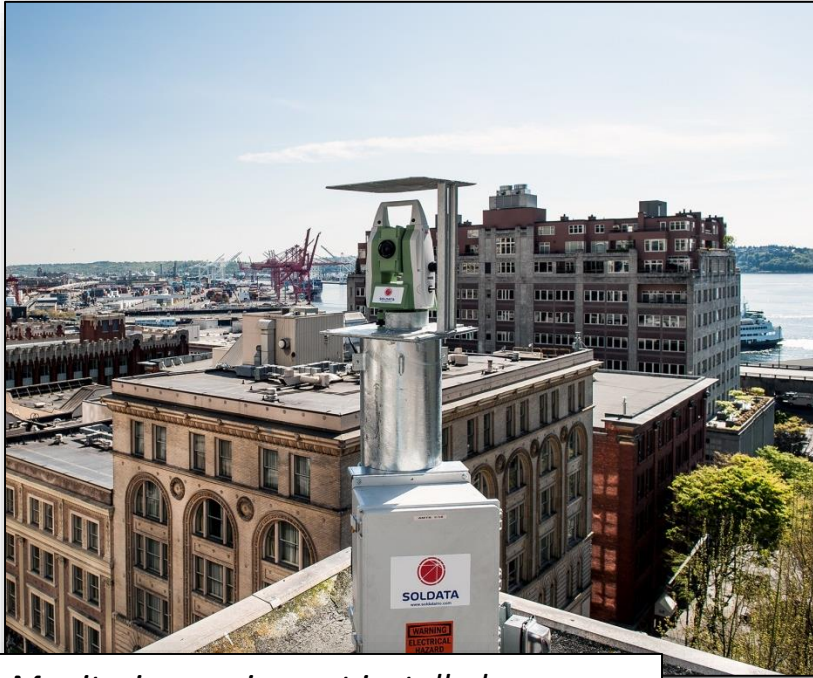
Monitoring equipment installed on a rooftop. Photo by Soldata.

- Install monitoring equipment on nearly 200 buildings.
- Install 700 instruments under streets and sidewalks to measure any ground changes.
- Track measurements of excavated material as tunnel boring machine progresses.
- Use satellite images to assess any changes in ground condition.

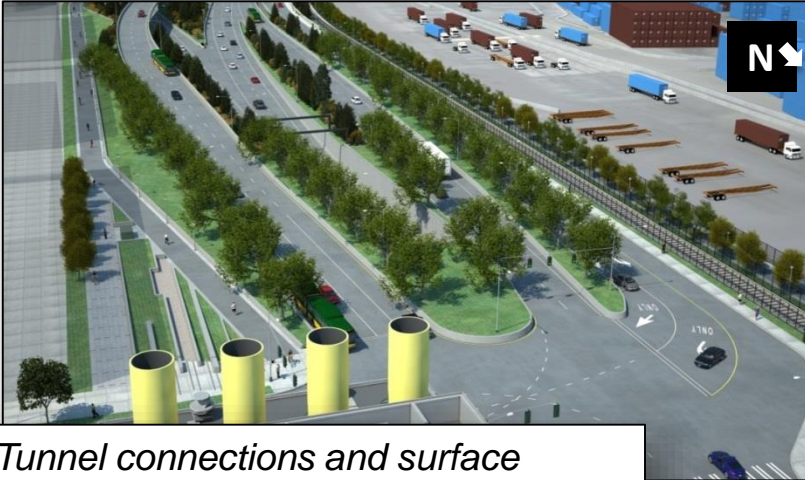
Tunnel connections and surface streets at the south tunnel portal

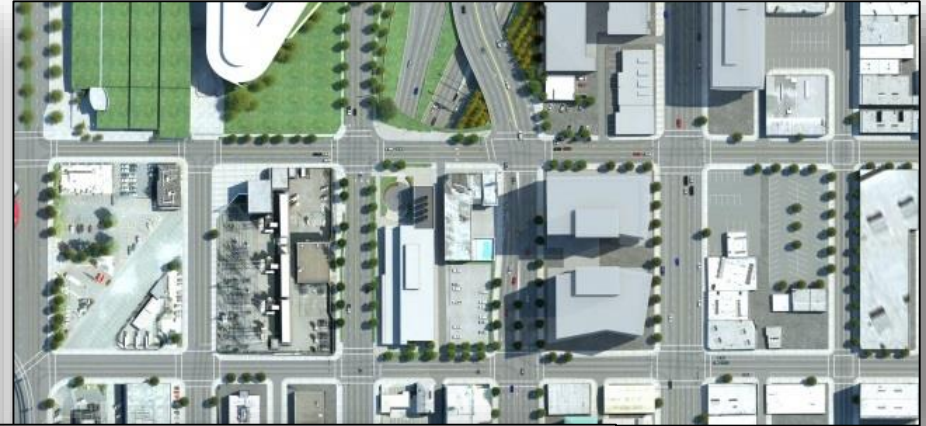
Reconnecting surface streets near the north tunnel portal

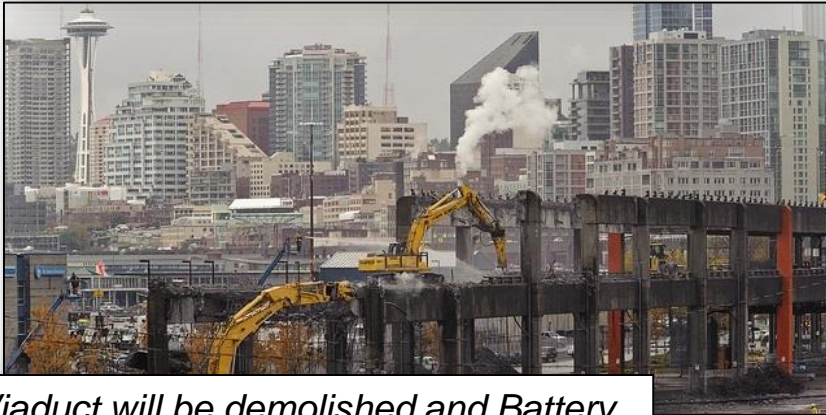
Viaduct will be demolished and Battery Street Tunnel will be decommissioned

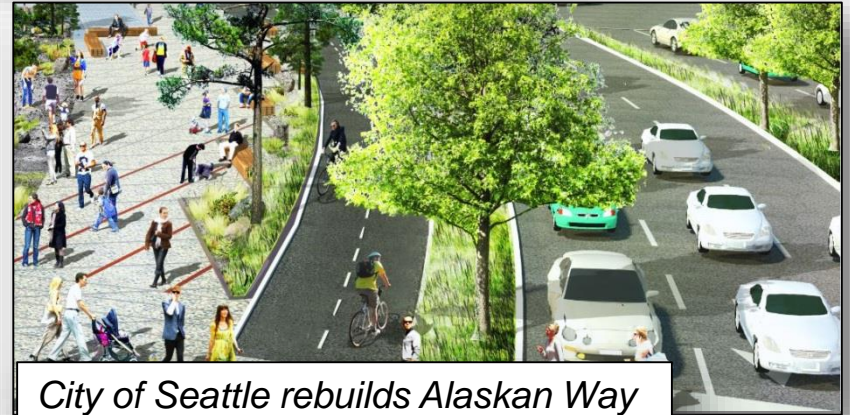
City of Seattle rebuilds Alaskan Way along the waterfront
