A Case Study

Dan Harpstead
Kleinfelder

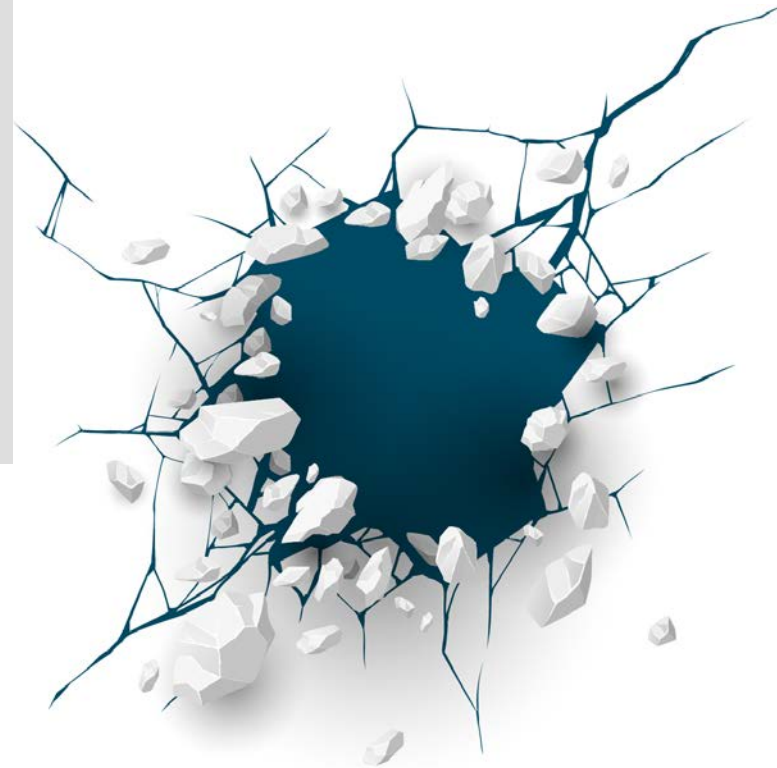
About one week after the big-box store opened, a portion of the **Lock + Load™** Retaining Wall fell onto an adjacent homeowner's property.

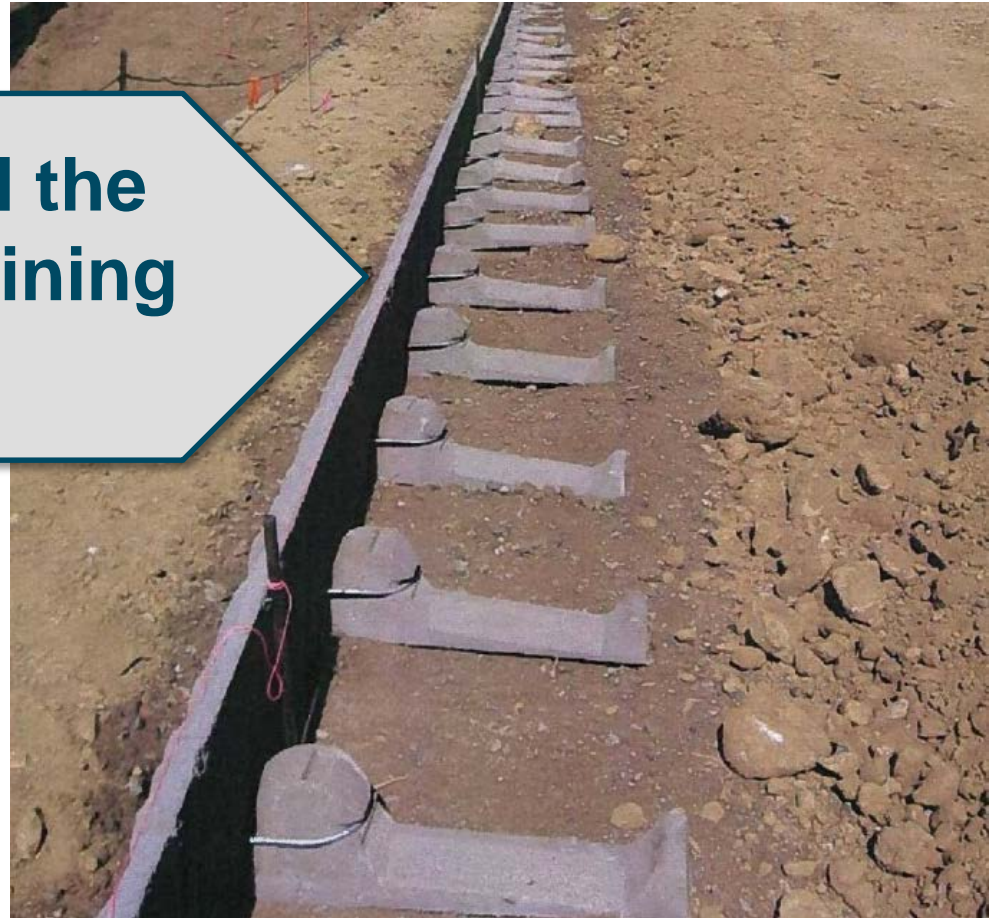
The client selected the
Lock+Load™ Retaining
Wall System

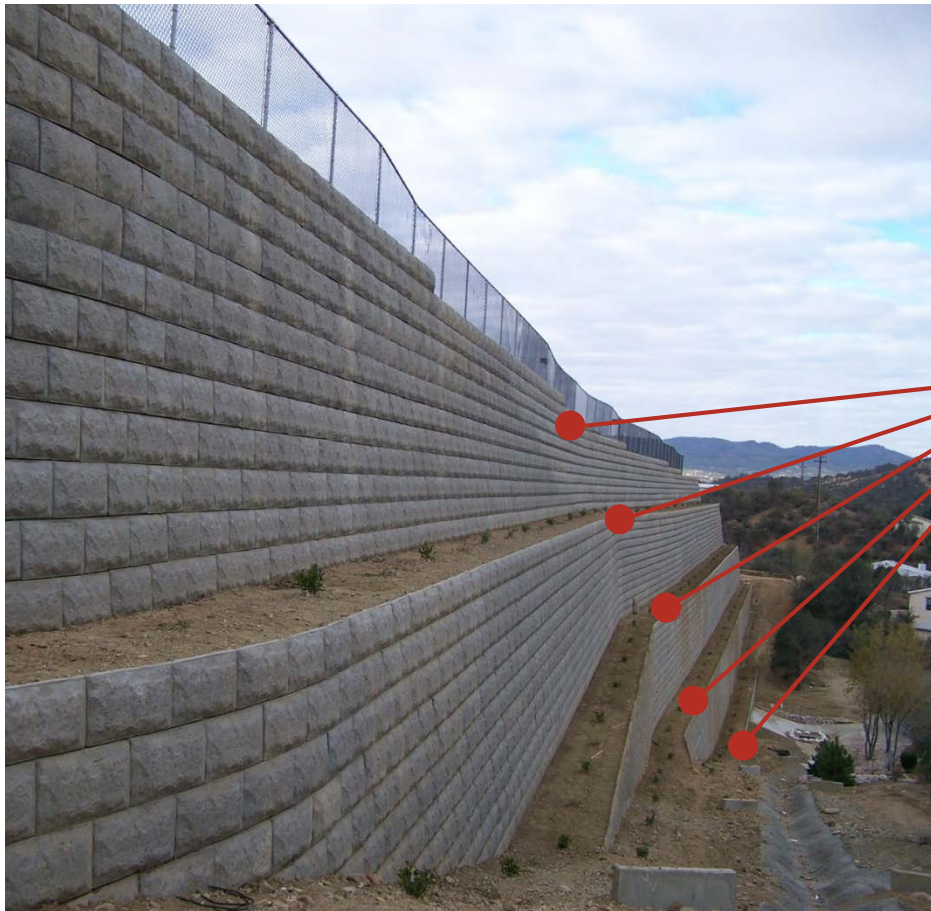
Comprised of
5 Walls

making it one of the
tallest **Lock+Load™**
walls ever built

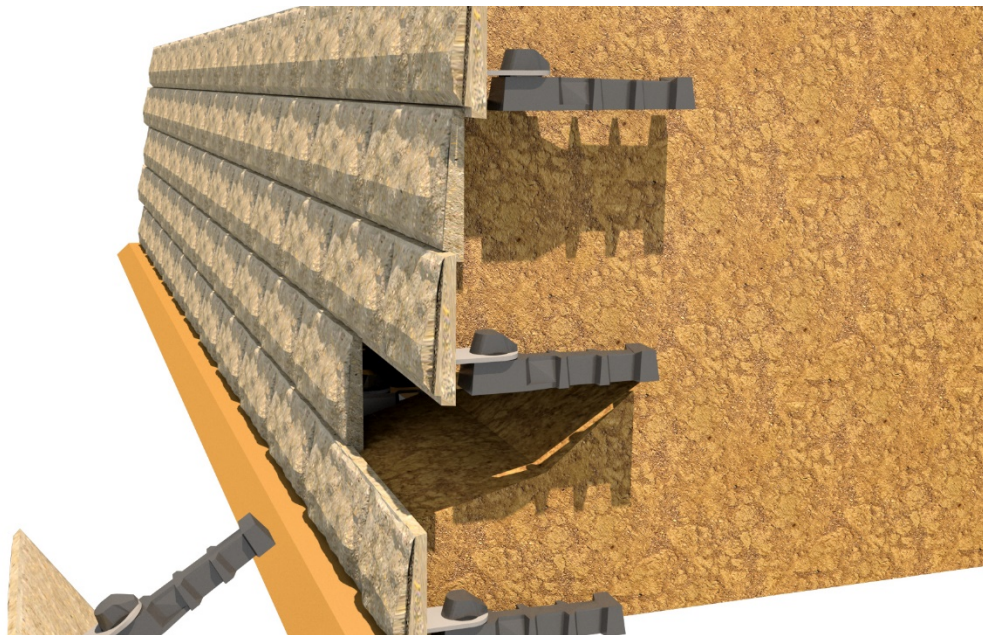
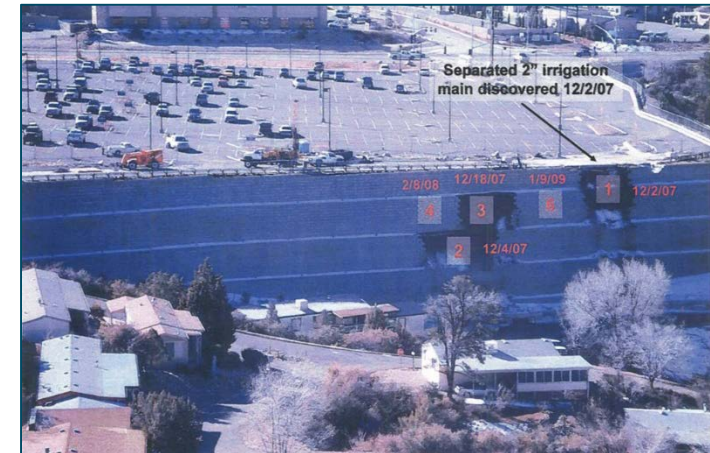
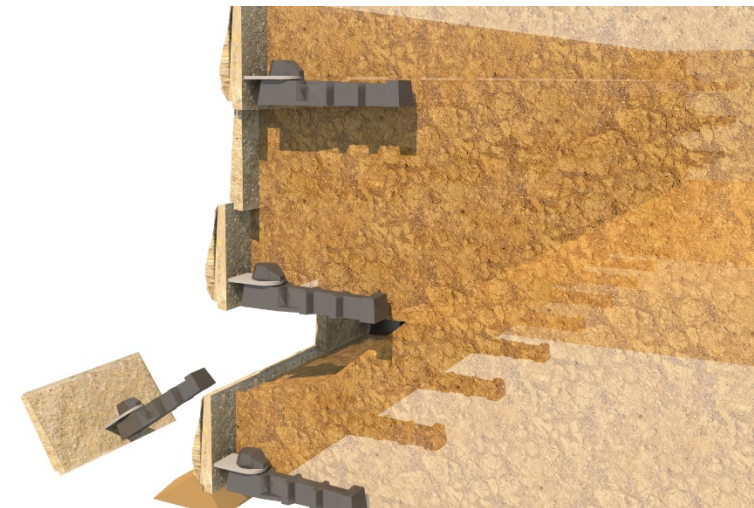
Side Bar - Lock + Load Design Vulnerability

Flaw in **Lock+Load™**
design logic
