# THE PENTAGON

PRESENTED BY :

**Leo J. Titus, Jr., PE**

ECS Group of Companies

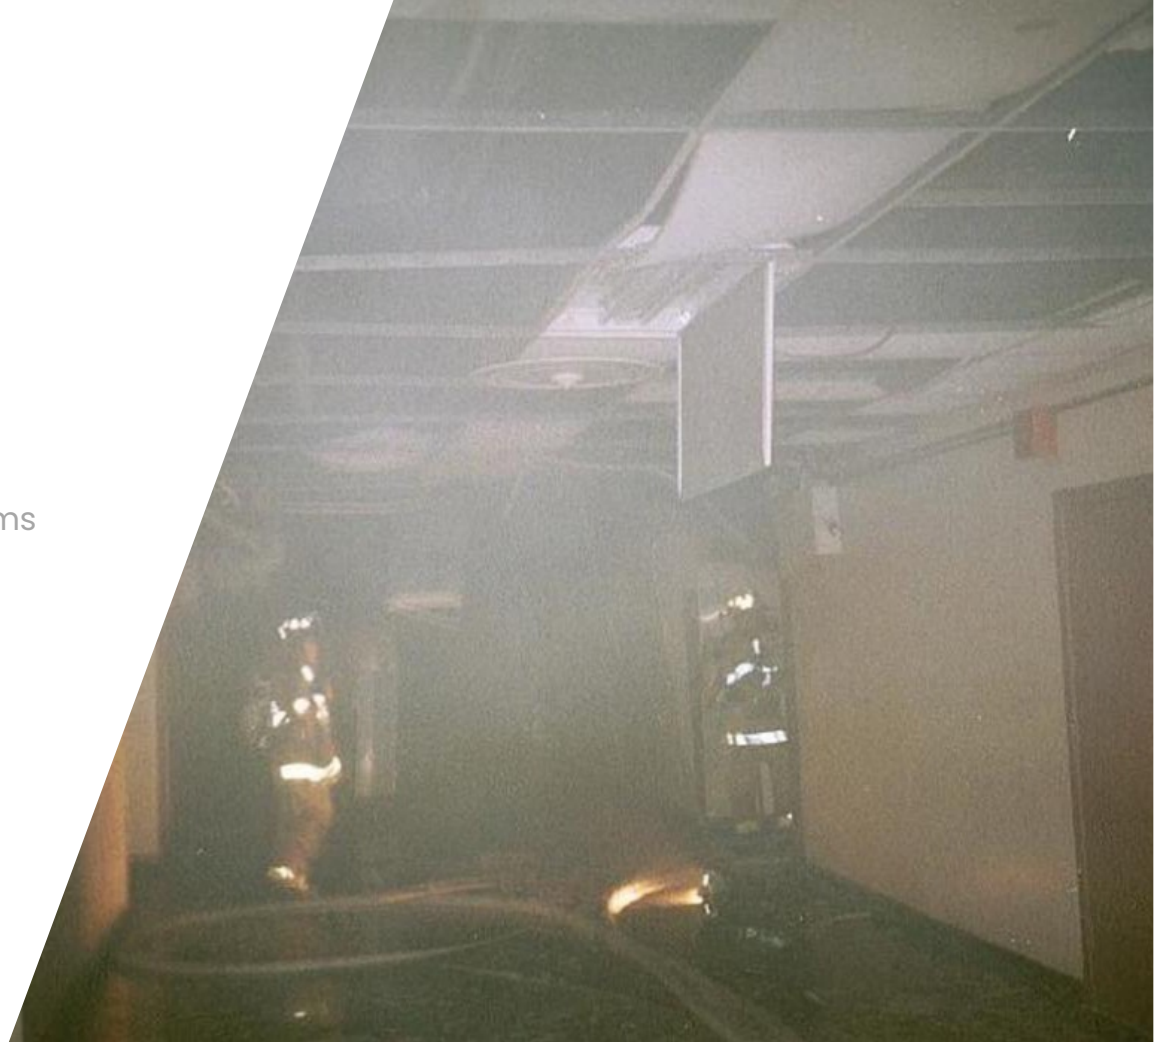
- 
- Significant internal damage on all floors.
  - Fire, smoke, heat, debris, water: all obstacles for recon team.
  - Floors too hot for canine teams.

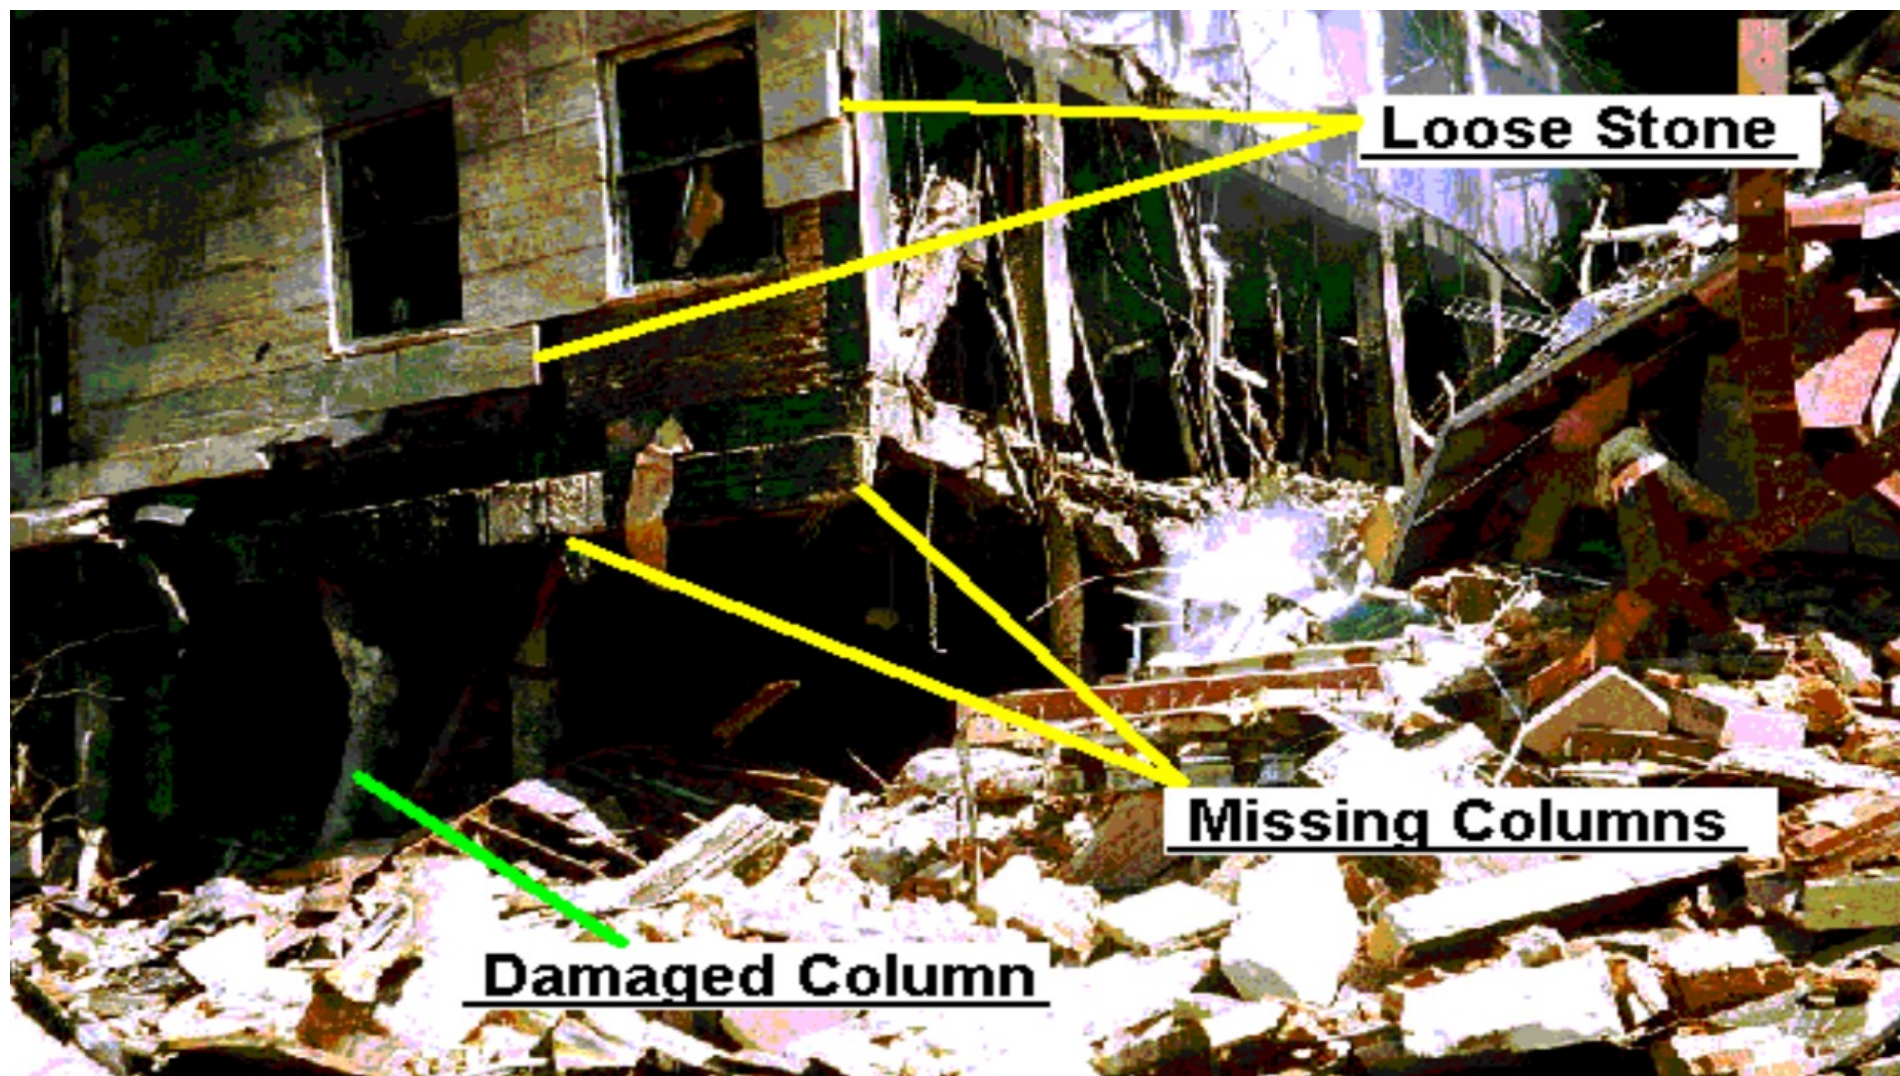
**Loose Stone**

**Missing Columns**

**Damaged Column**

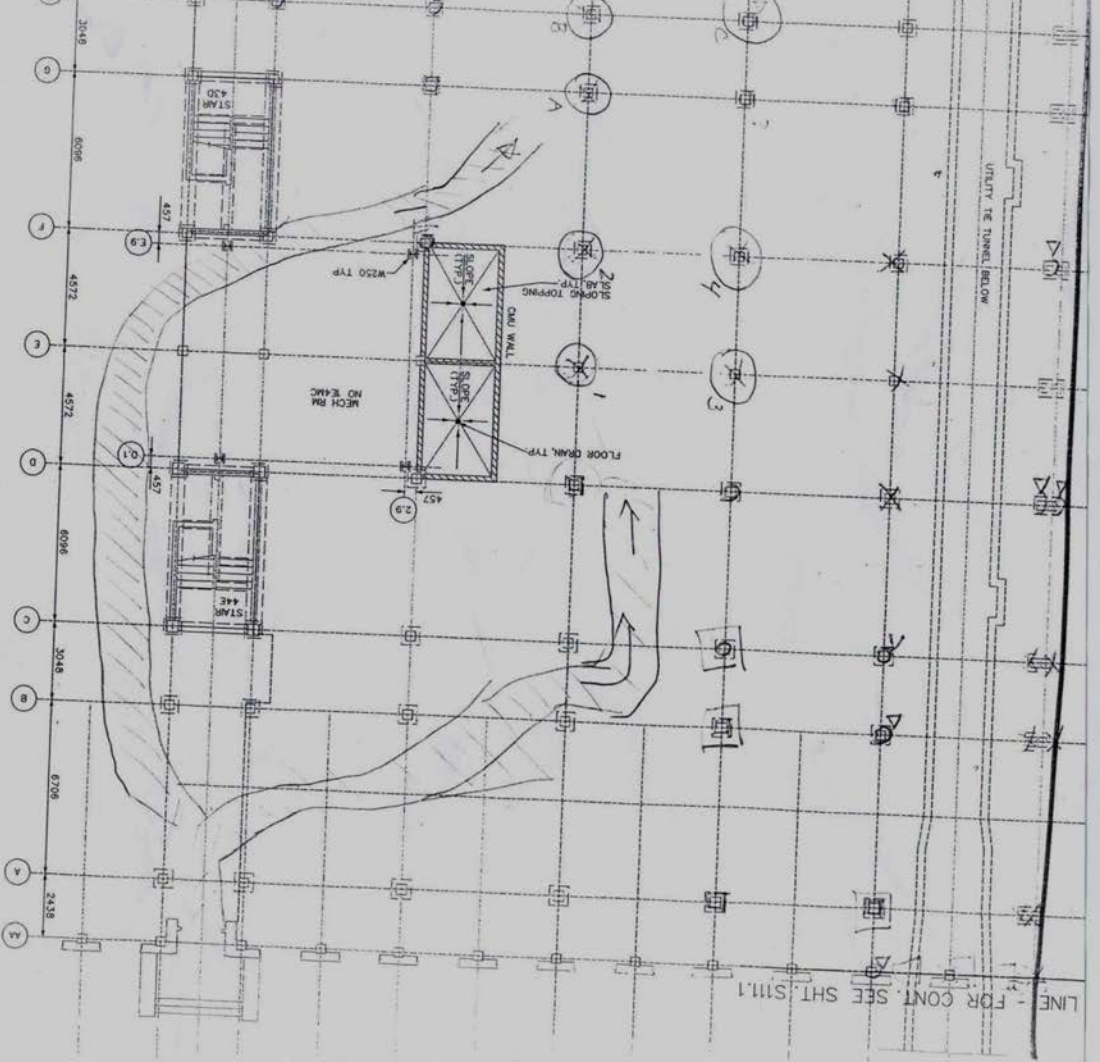
Over **42**  
columns  
required  
shoring on  
the first floor.

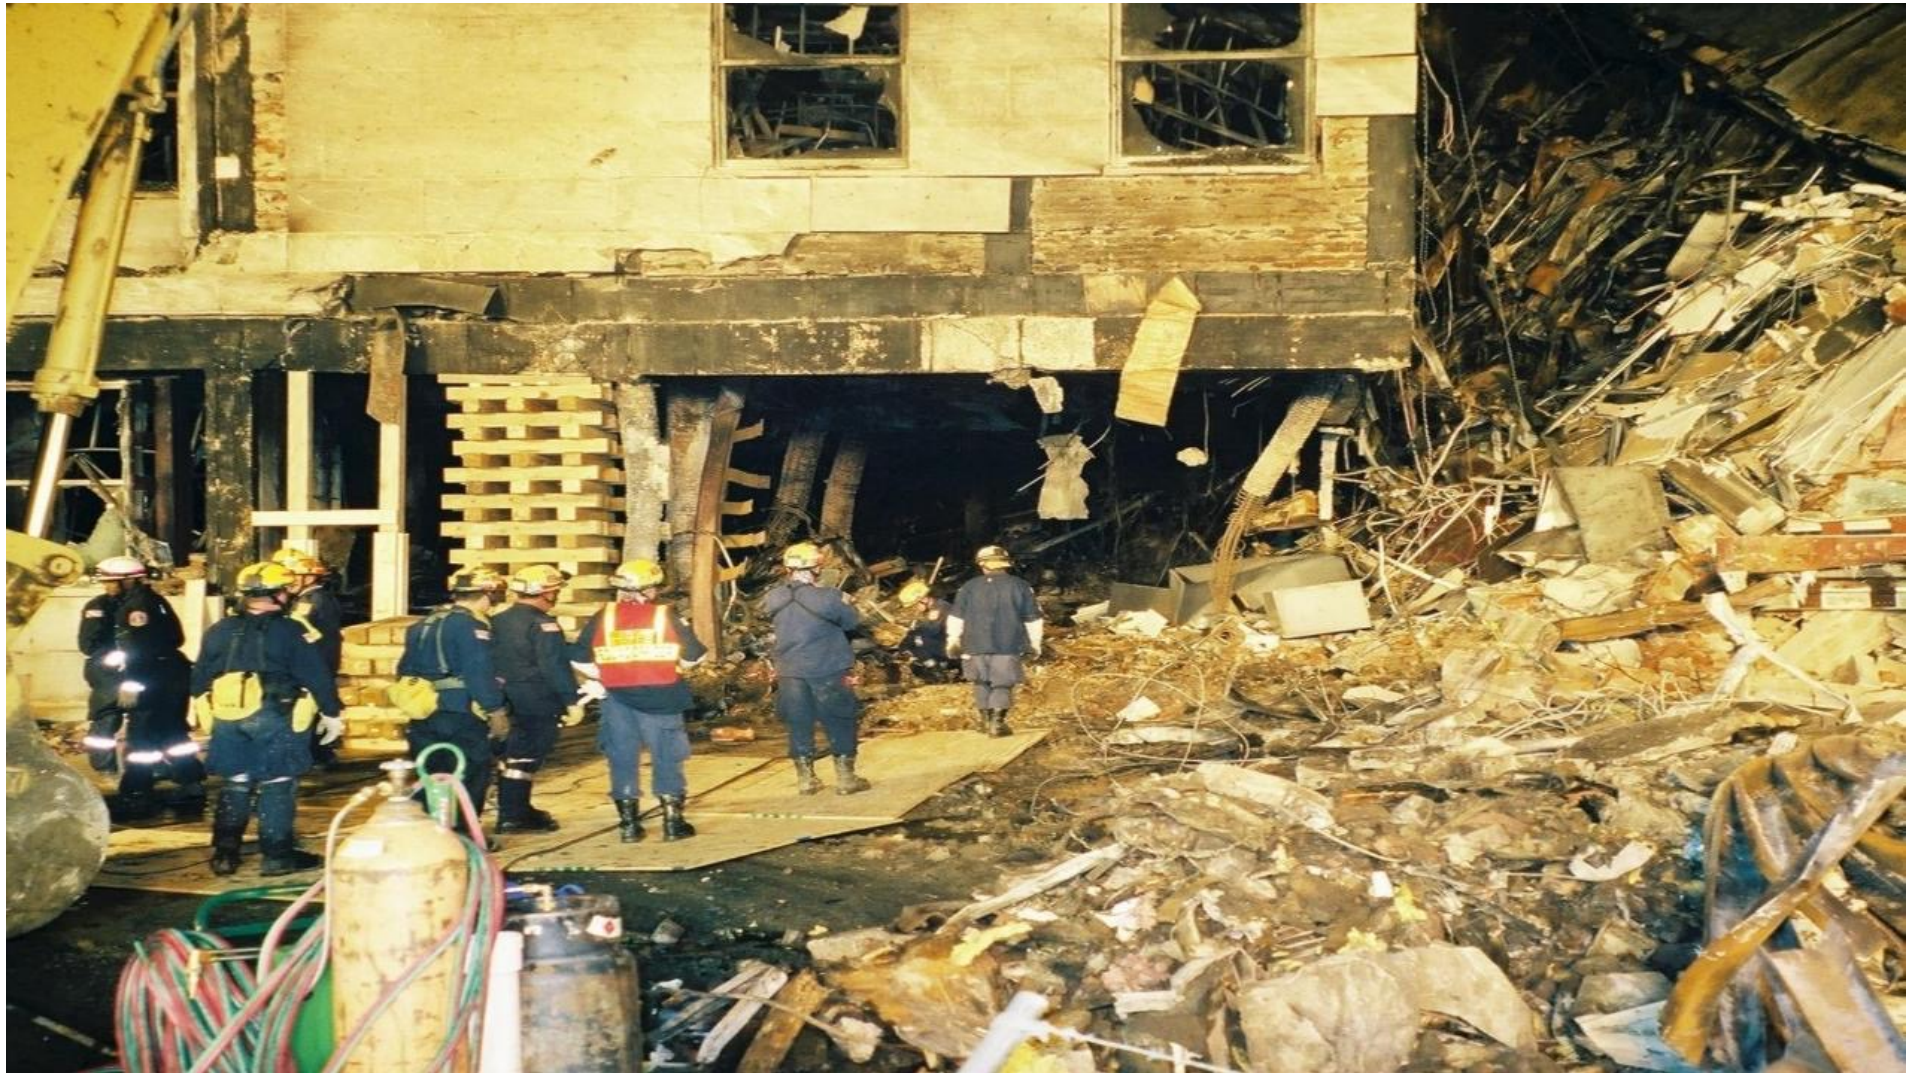
- 3 vertical crib shores used on front corner
- 6"x6" lumber used for cribbing

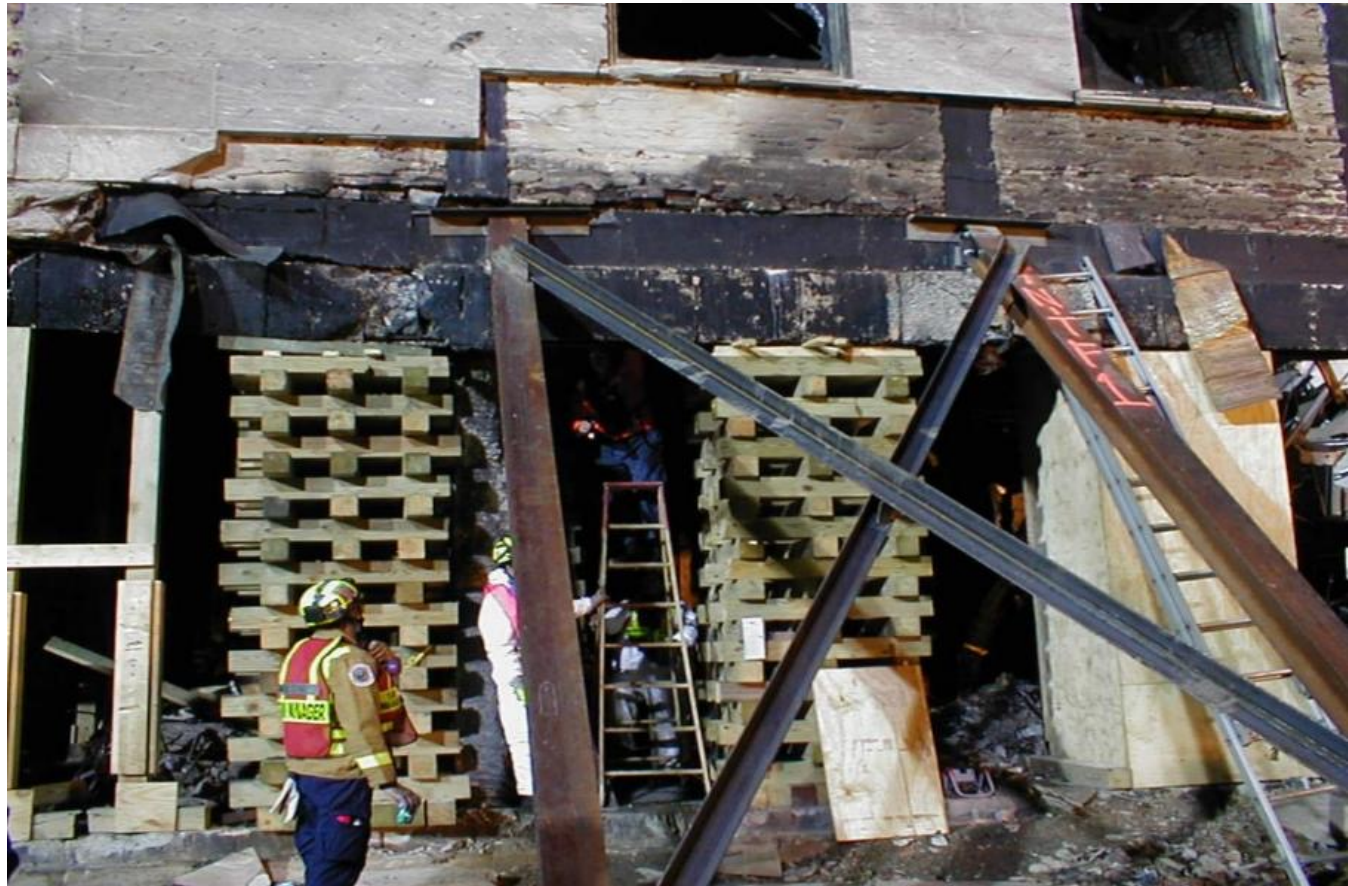
- Raker Shore constructed for lateral support
- Knocked off "Widowmakers"

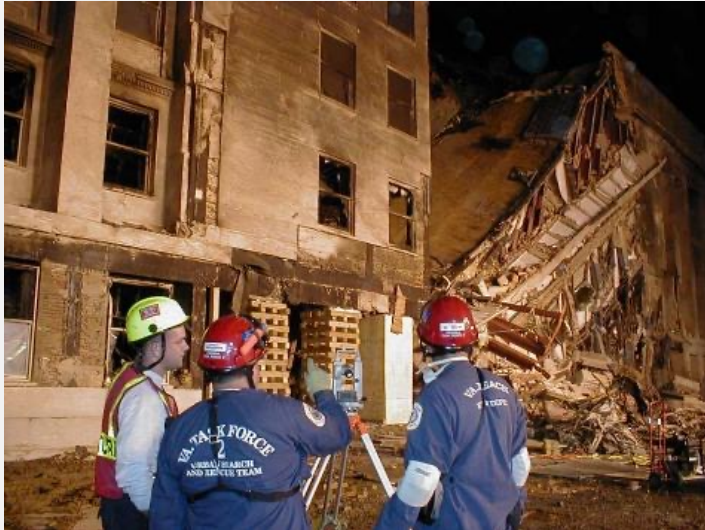
## Monitoring Building Movement

- 2 points monitored all week with transits
- Cantilevered corner
- Hanging concrete parapet

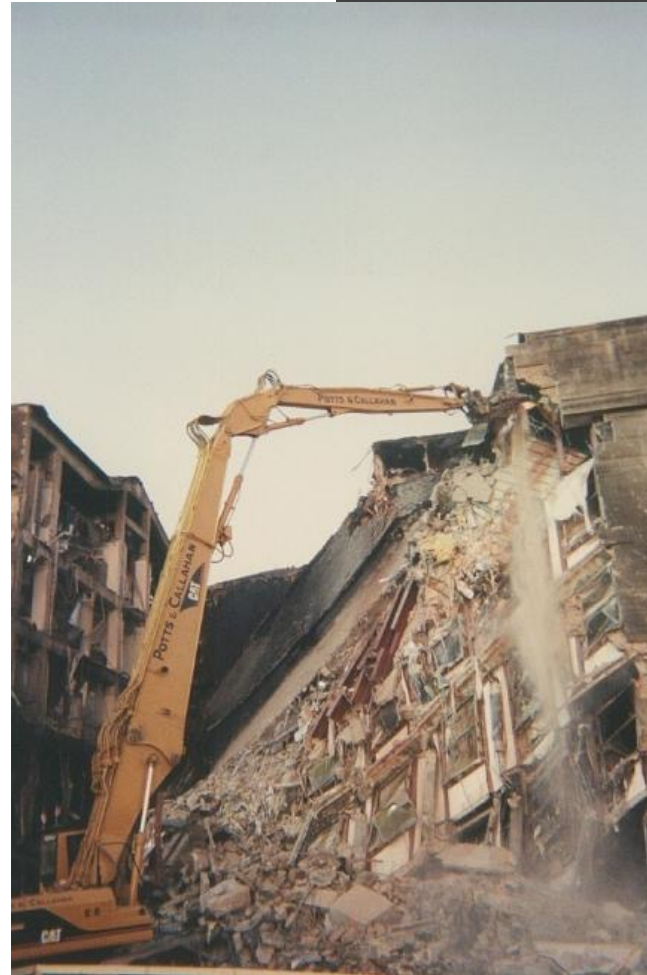
- “Pulverizer” used to break up concrete safely.

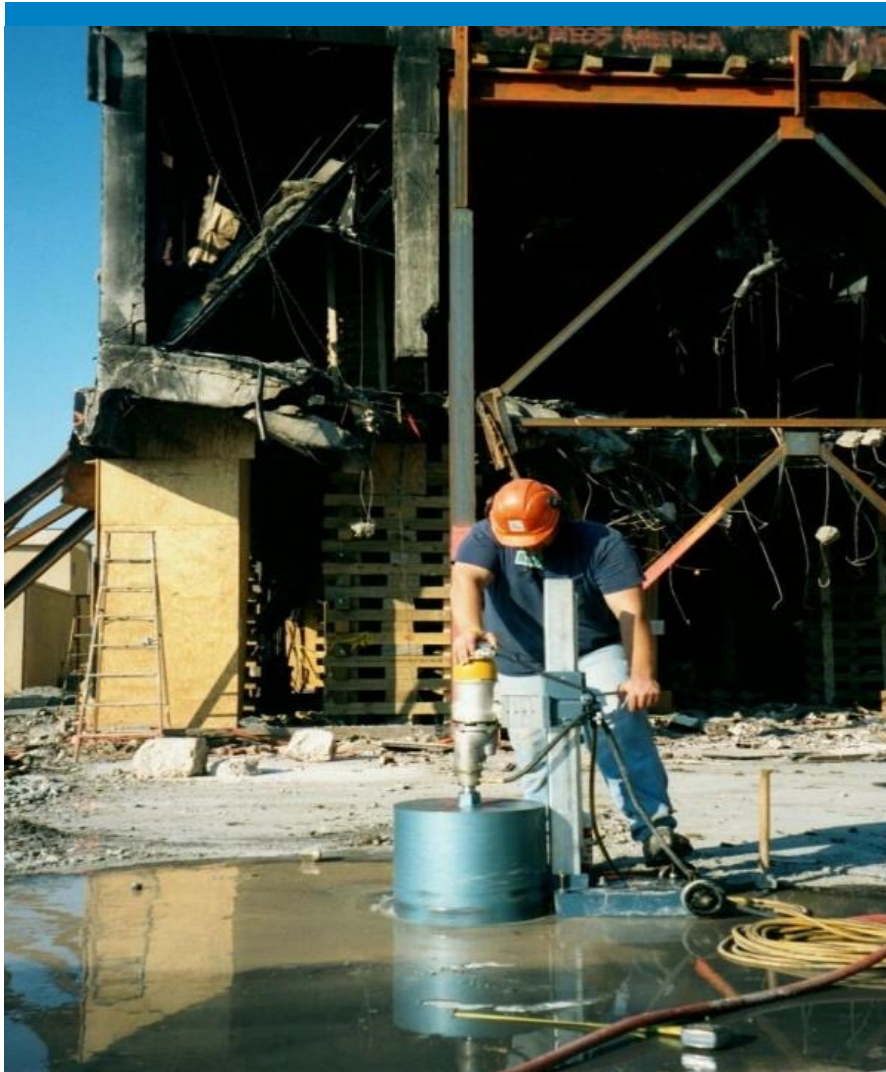
Sampling Concrete

Pile Load Testing in Collapse Area

Helical Anchor Piles

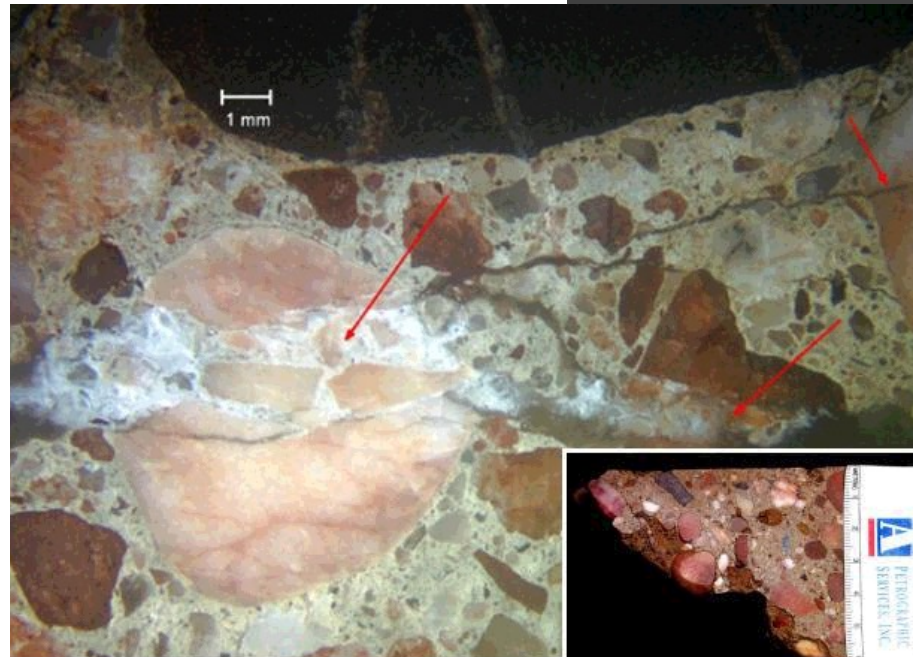
Saw-cut cross section of concrete from the support columns showed numerous micro-fractures.
