How the Geoprofessional Avoided a Lawsuit and Saved the Owner \$6 Million!

Michael J. Byrne, Esq.
Byrne & O'Neill, LLP

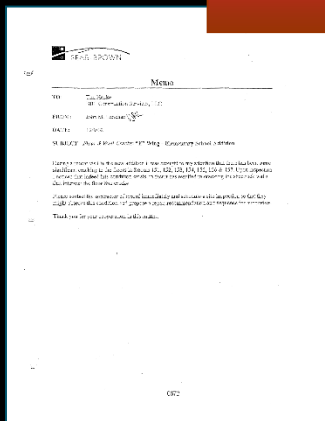
Cracking In South Wing Is Reported To SBA – R5

24 Months After
Foundation Placed

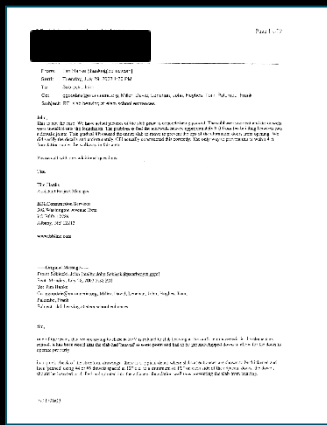
████████ Memo Re Slab Heave At North Entrance – R8

Subject: slab heaving at elem school entrances

one of the issues that we are trying to chase at FFV is related to slab heaving at the north entrance/exit in the elementary school. it has been noted that the slab had 'heaved' at some point and had to be ground/chipped down to allow for the doors to operate properly.

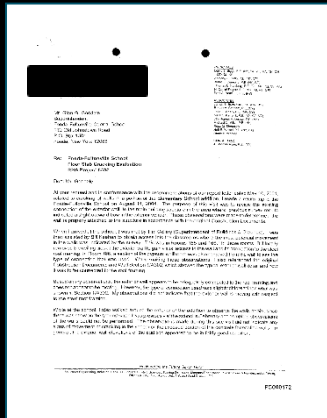
Report – Slab Has Raised/ Aesthetic Problems Only – R17

Based on my observations, the exterior wall appears to be adequately connected to the roof framing and does not appear to be moving. However, the type of connection used was slightly different than what was shown in Section 1/A302. My observations did not indicate that the exterior wall is moving with respect to the steel roof framing.

of the walls could not be performed. The observations made during this site visit did not indicate any signs of movement or cracking in the veneer or the exposed portion of the concrete foundation walls. In general, the exterior wall elevations of the addition appeared to be in fairly good condition.

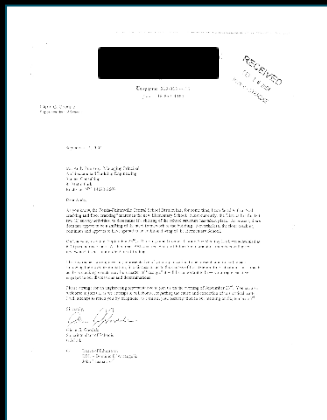
Letter – No Structural Movement – Floor Cracking Spread To Other Wing – R20
