Friends Don't Sue Friends.....Most of the Time

**CASE
HISTORY** | NUMBER
105

Dan Schaefer, P.E.
Froehling & Robertson, Inc.

A Series of Unfortunate Events

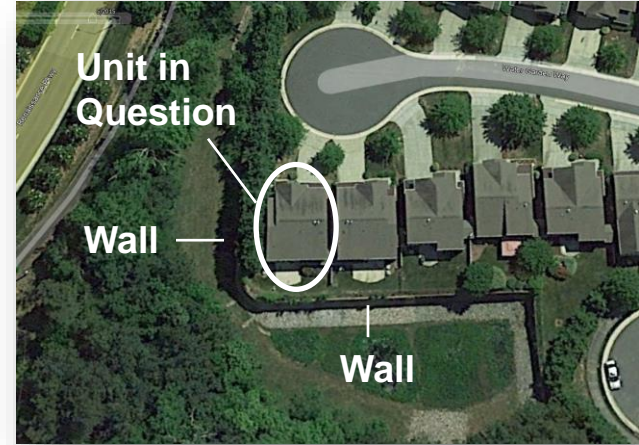
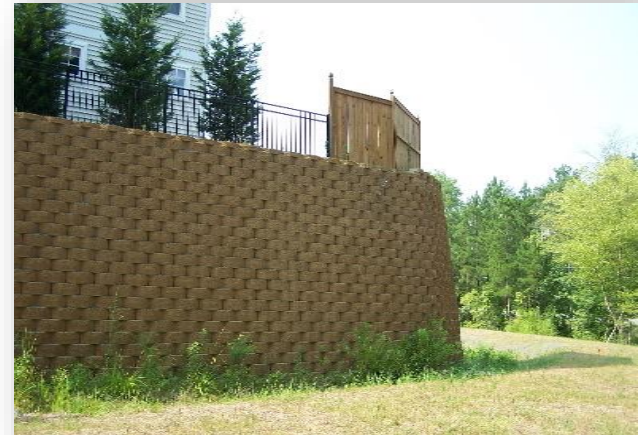
- Client – National Homebuilder – LD Division
- Project – New Townhouse Development
- Structure – Two-Story Townhouse on Monolithic Slab Foundation
- Wall – 18' Tall MSE, 20' from Structure
- Member Firm Assignment – CoMET Services During Construction of an MSE Retaining Wall
- Construction - 2004
- Claim/Lawsuit - 2007 to 2009

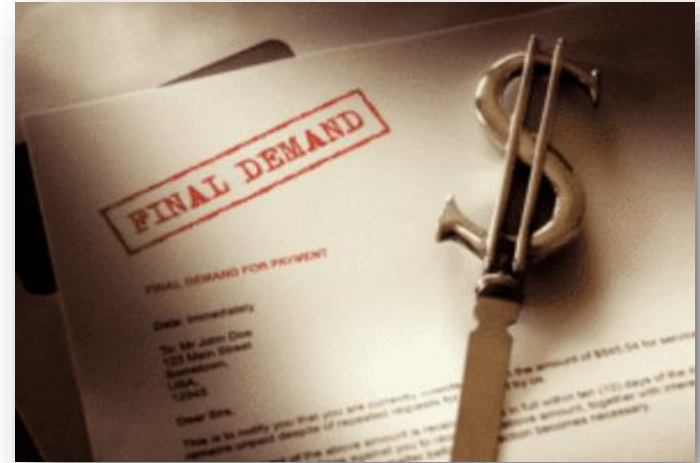
- Client Sent Demand Letter
- Claimed We Were Aware of Issue
- Claimed Retaining Wall Has Failed
- Seeking Reimbursement For Repair from Designer, Contractor & CoMET provider
- 10-Day Notice Before Starting Repairs
- Insufficient Time to Perform Proper Evaluation
- Could Not Stop the Direction of the Issue

- Owner's Expert Overkilled Repair
- Townhouse: Helical Pier Support
- Wall: Soil Nail Repair
 - 30' Soil Nails
 - 6" Shotcrete Facing
 - Extended >75 feet in each direction
- Several Other Repair Options Available

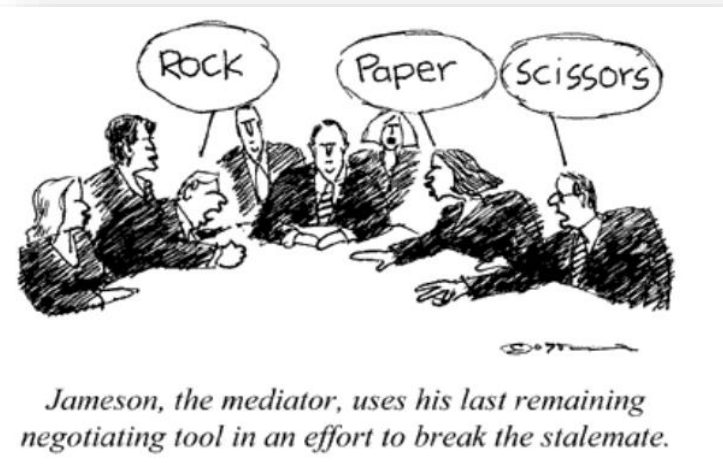
- Contractor
 - Represented by GLI Carrier
 - Carrier Gave Up and Offered \$75,000
 - Most At Fault in Poor Wall Construction
- CoMET Firm
 - Deep Pocket, Felt We Had Good Case
 - Attorney Pushed for Settlement
 - Settled for \$75,000 in 2009, PLI covered \$25k
 - Cost over 100 hours plus Legal Fees
 - Big Distraction and Added Stress
- Designer
 - Small Firm
 - Incensed To Even Be Named in Claim
