Selway Slide Emergency Repair

Travis J. Wambeke, P.E., P.G.

GeoProfessional Innovation Corporation

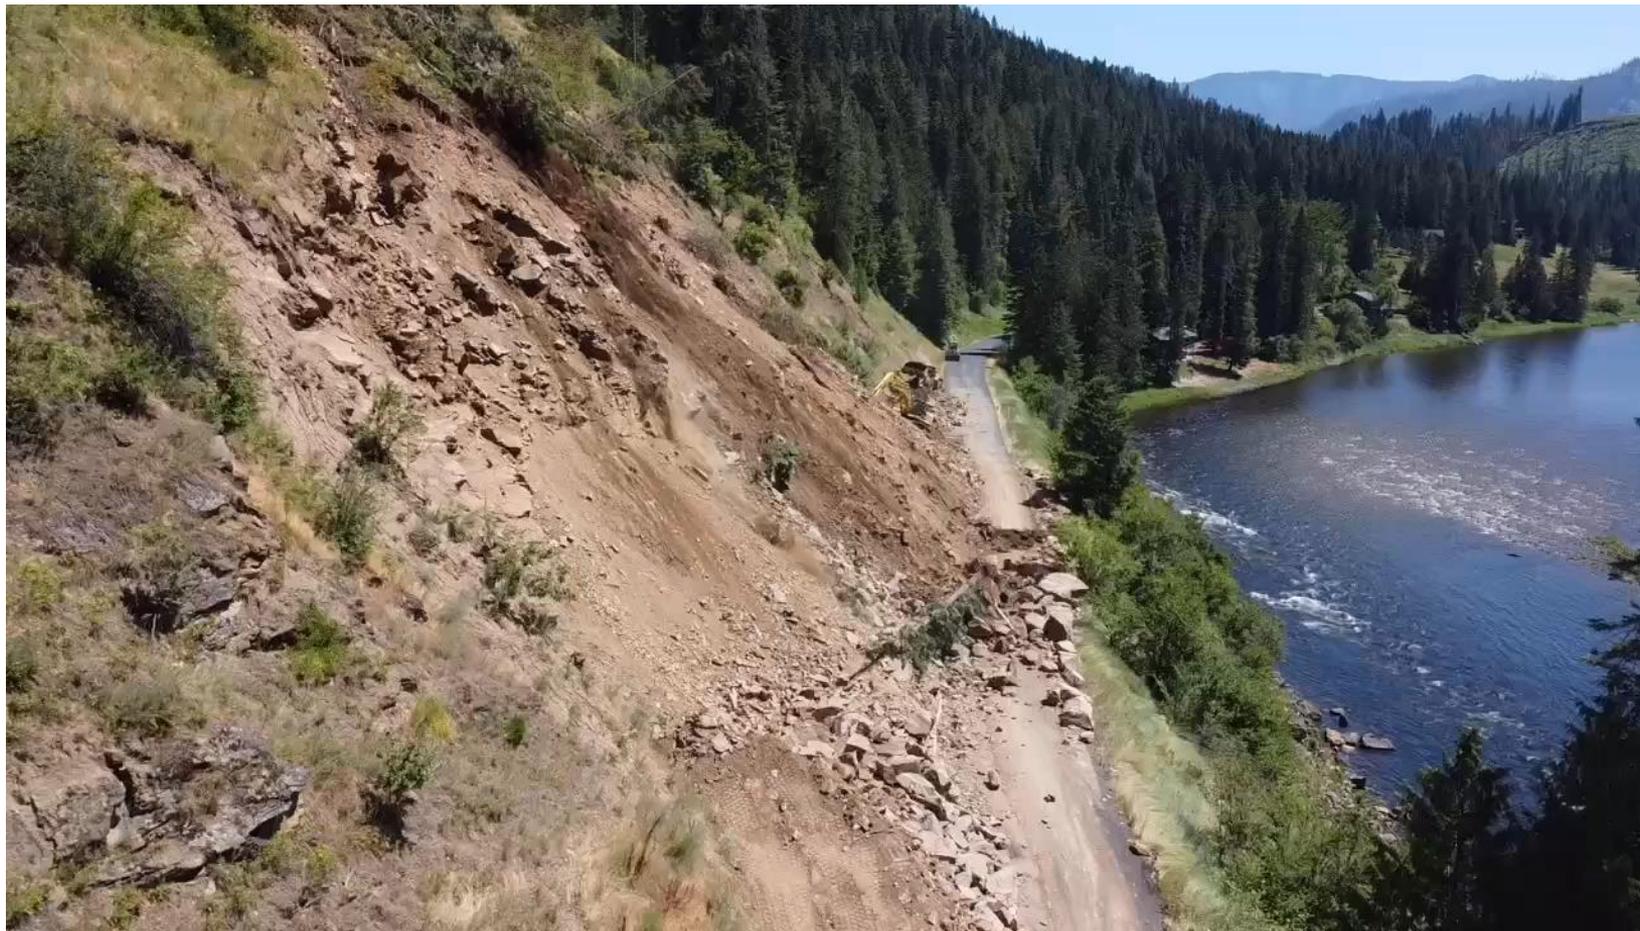
July 15, 2022 Landslide

- 30' debris field on roadway
- 500' of blocked roadway
- 90,000+ yd³ soil and rock
- Blocked critical access for firefighting, material supplies, public & private access

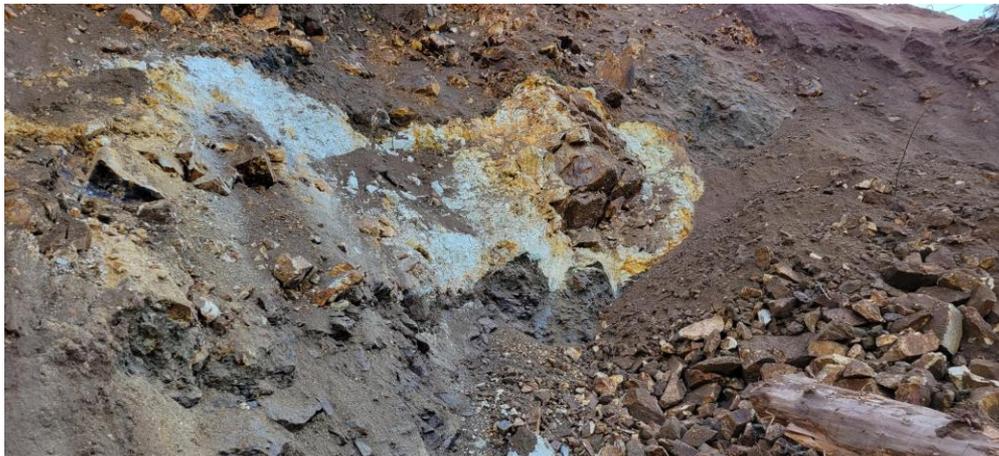
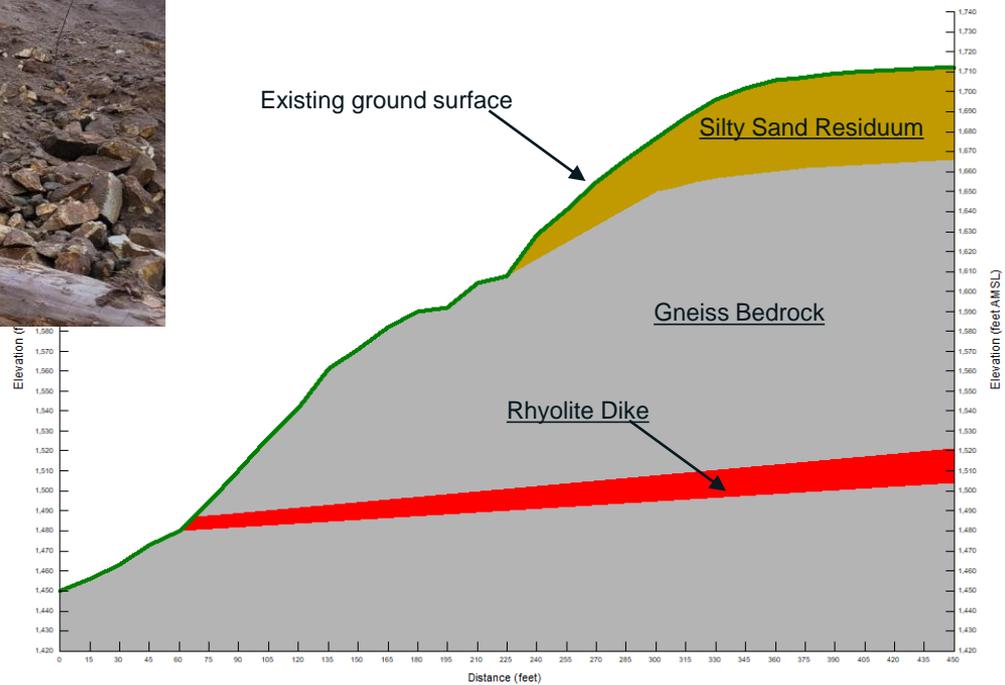
The Culprit: Rhyolite Dike

- Vertical scarps in areas
- Wedge failure planes dipping towards roadway
- Progressive plane shear failure
- Instigated circular failure in residual soil
